# 2015 RETAINING WALL CONDITION REPORT

**City of Cincinnati**

**Department of Transportation and Engineering**

**2015**

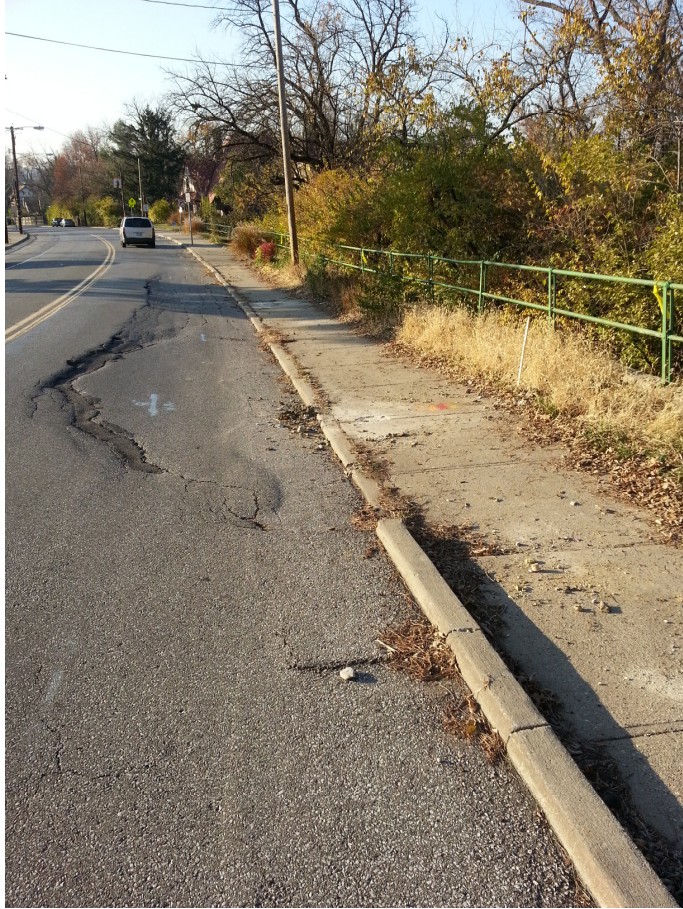
The Clinton Springs retaining wall east of Laymen Avenue was stabilized in Calendar Year (CY) 2015. The retaining wall originally constructed in 1948 was built within a landslide mass which continually moved down slope. Movement of the landslide mass and the wall impacted the westbound lanes of Clinton Springs. The Capital Improvement Project consisted of underpinning the existing wall by the installation of 26 Drilled Shafts, construction of a wall cap and replacement of the railing. The piers were attached to the wall with reinforced concrete buttresses. The piers were anchored in stable bedrock to immobilize the wall and retain the earth under the street. The retaining wall stabilization was done as part of the Clinton Springs and Mitchell Rehabilitation (SCIP) Project. Fifty percent (50%) of the construction cost, \$67,172.55 was certified for construction from the Wall Stabilization and Landslide Correction Program. The other fifty percent (50%) was funded by the State Capital Improvement Program (SCIP).

Clinton Springs looking west prior to repairs.

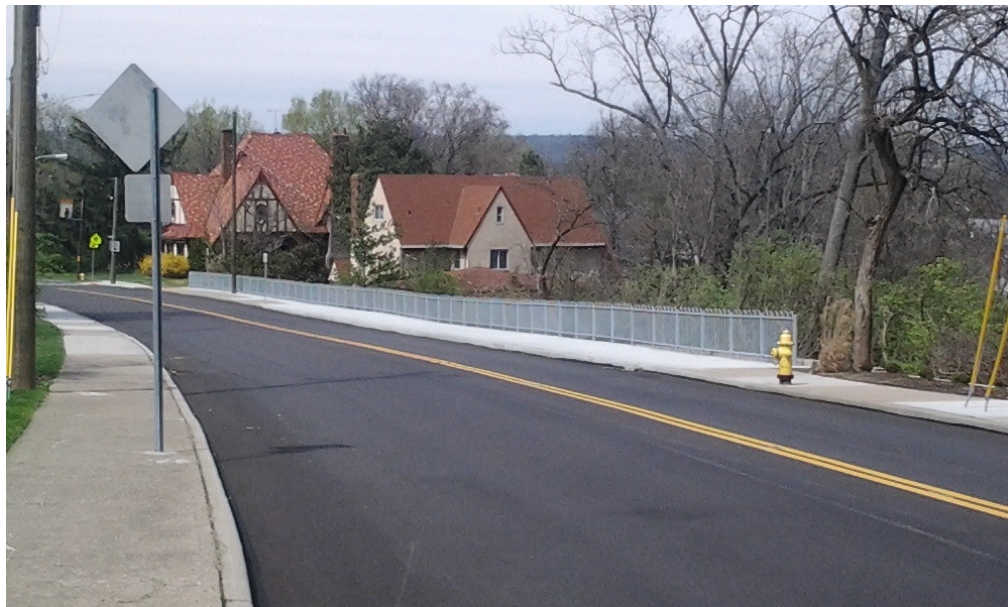
Clinton Springs looking west after repairs.

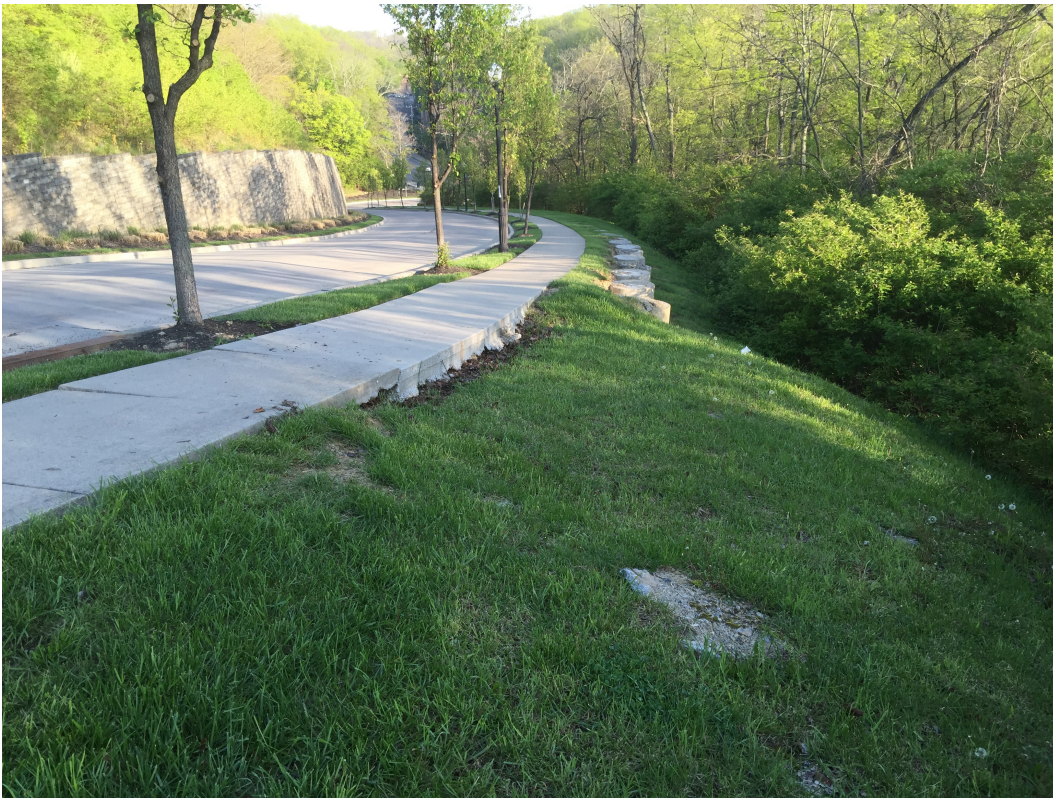
The original Ridgetop Way Pier Wall was constructed in 2003 by the developer of the Woodcrest Park Development to separate a landslide from Ridgetop Way. The wall consists of thirty-two (32) thirty (30) inch diameter piers. Overtime the landslide on the downhill side of the pier wall enlarged and extended beyond the limits of the original pier wall. The enlargement of the landslide damaged existing sidewalk. Additional movement would eventually affect the roadway pavement.

Ridgetop Way looking towards Queen City Avenue showing existing wall and undermining of sidewalk. Headscarp of landslide extends into the forward lawn area.

This contract involves the extension of the existing pier wall on Ridgetop Way. The extension consists of the installation of eight (8) thirty inch diameter drilled shafts. Precast concrete panels are to be placed between the piers. A cast in place wall cap will be constructed on top of the proposed panels and a section of the existing panels. A section of the existing sidewalk is to be removed and replaced.

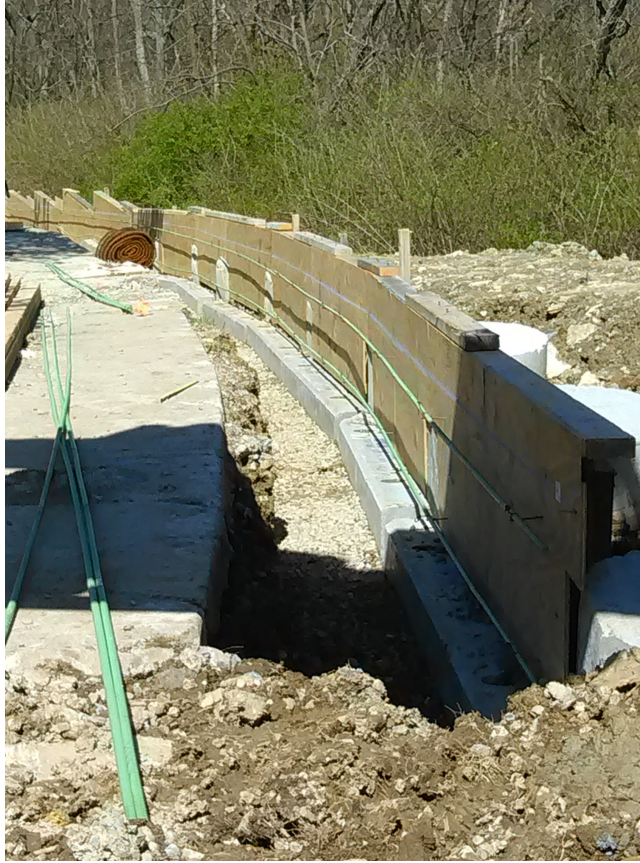
Forming for wall cap on Ridgetop Way Pier Wall Extension.

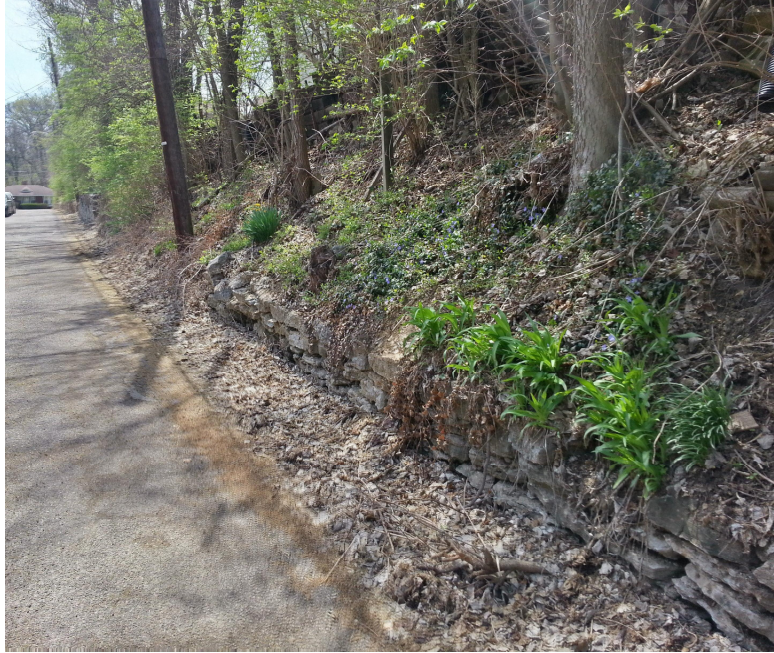
The Hoadly Court retaining wall was originally constructed in 1930. The wall is a gravity wall composed of mortared limestone. The wall has a length of 312 feet with heights varying between two and four-and-a-half feet. The retaining wall had a Structural Rating of 4 (Critical) due to several wall failures along its length. Sections of the wall were rebuilt by the Transportation and Roadway Operation Division (TROD) in 2015 by Interdepartmental billing at an expense of \$15,856.

Hoadly Court looking south prior to wall repairs.

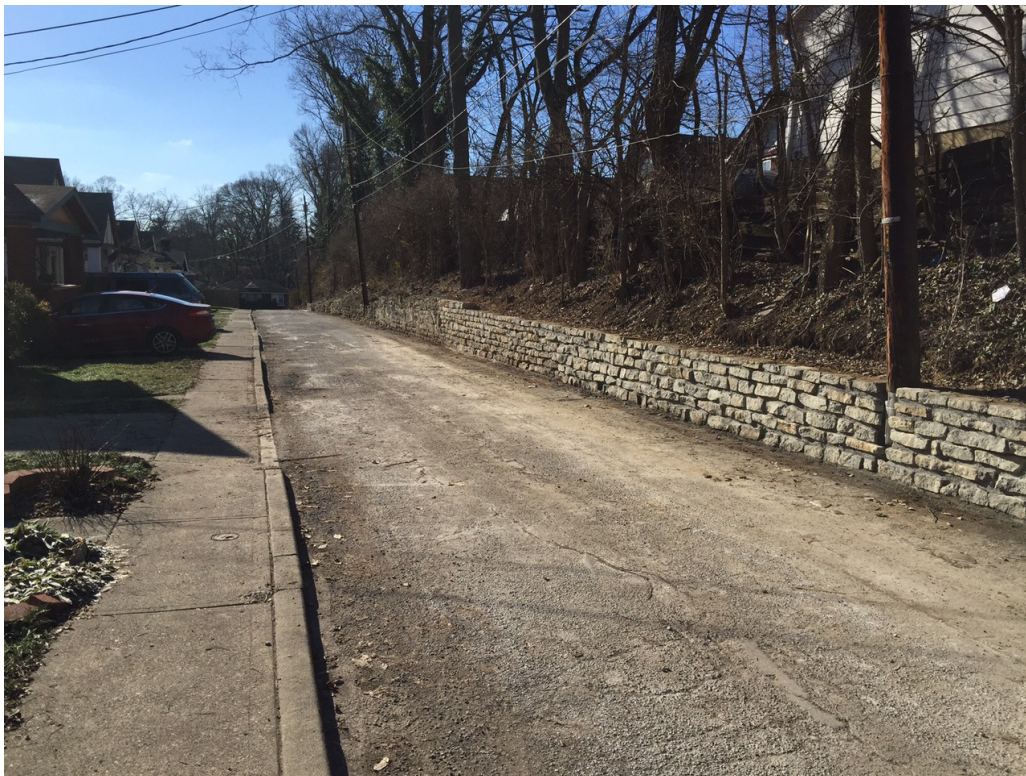
Hoadly Court looking south after wall repairs.

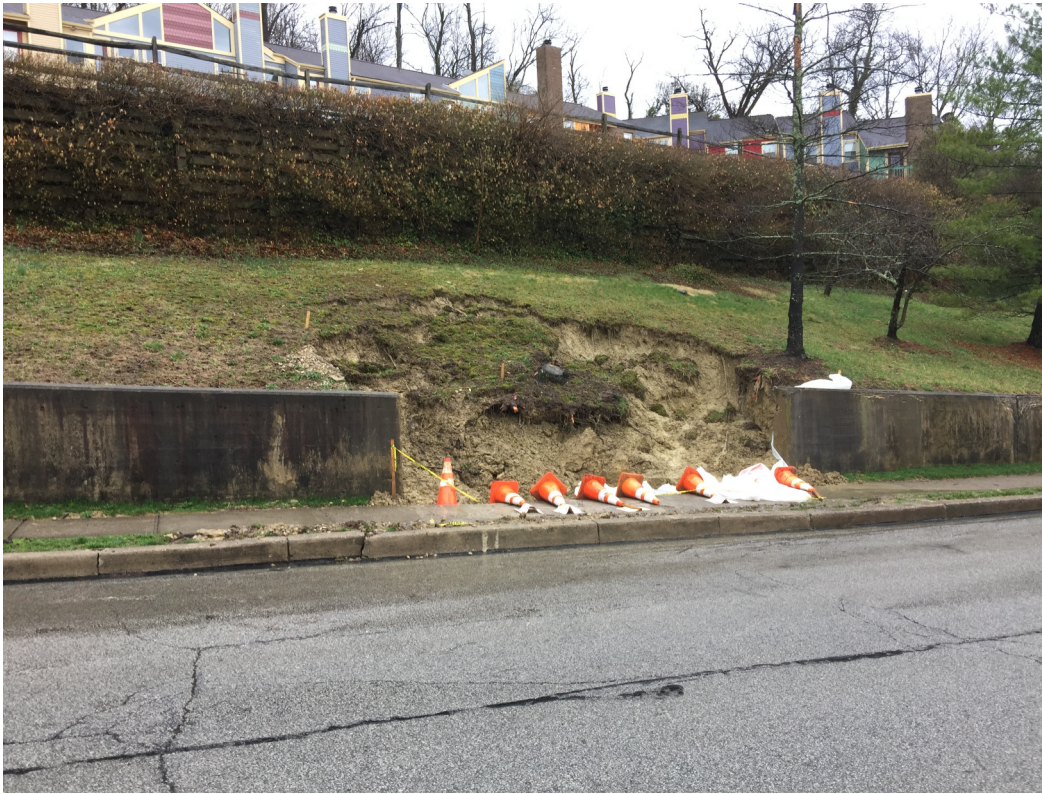
A twenty-five foot section of a reinforced cantilevered retaining wall began to tilt in 2015. The wall eventually failed due to corrosion of the vertical steel which connected the wall stem to the footing for the wall. Under the direction DOTE, TROD replaced the wall with a segmental wall which was then faced with concrete to maintain original character of the wall. The section of wall was replaced at a cost of \$15,965.

Tusculum Avenue after wall failure. Failed wall stem has been removed.

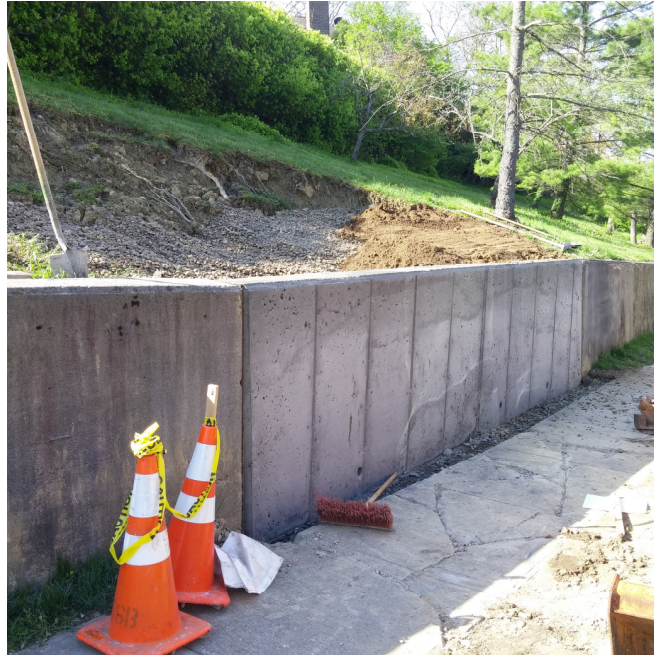
Tusculum Avenue after completion of wall stem and prior to backfilling and sidewalk replacement.

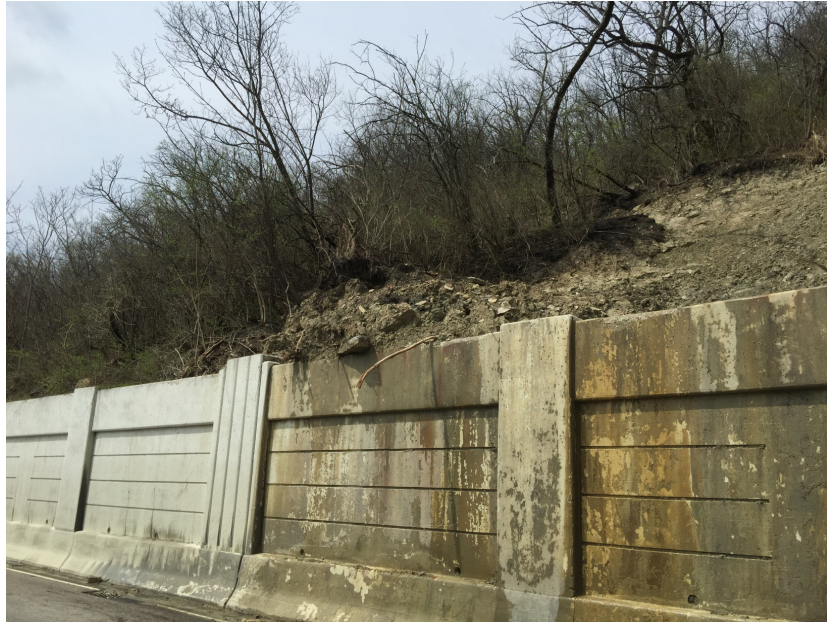
Slide debris was removed from Columbia Parkway on two occurrences in CY 2015. The first occurrence was a preventive removal at two locations which threatened to slide onto the roadway.

Small debris removed from atop Columbia Parkway Wall.

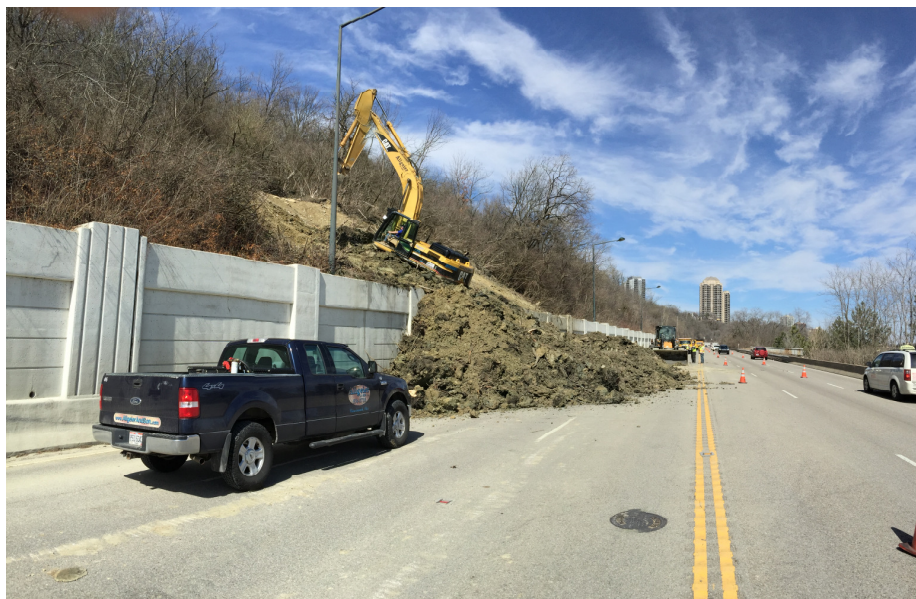
Removal of slide debris from Columbia Parkway approximately 2,000 feet west of Kemper Lane.

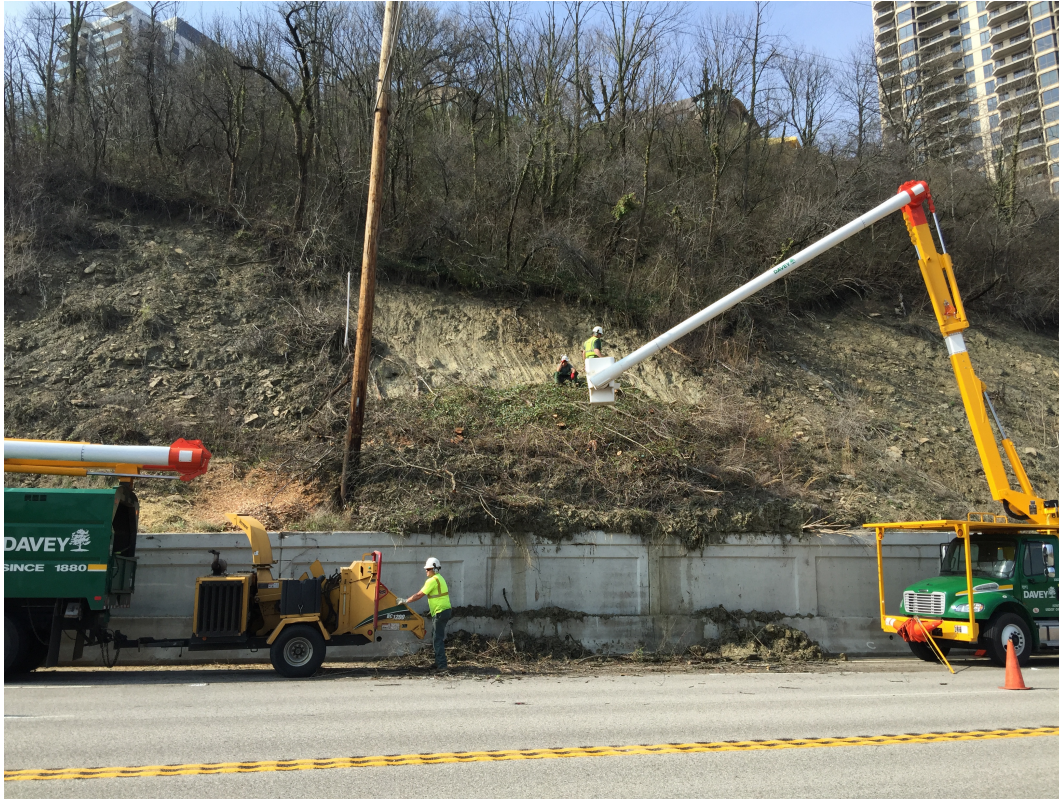
The second occurrence was in response to a newly formed slide mass which slid to the top of the retaining wall and would have eventually slid onto the roadway if it was not removed.

Removal of slide debris from Columbia Parkway approximately 600 feet east of Kemper Lane.

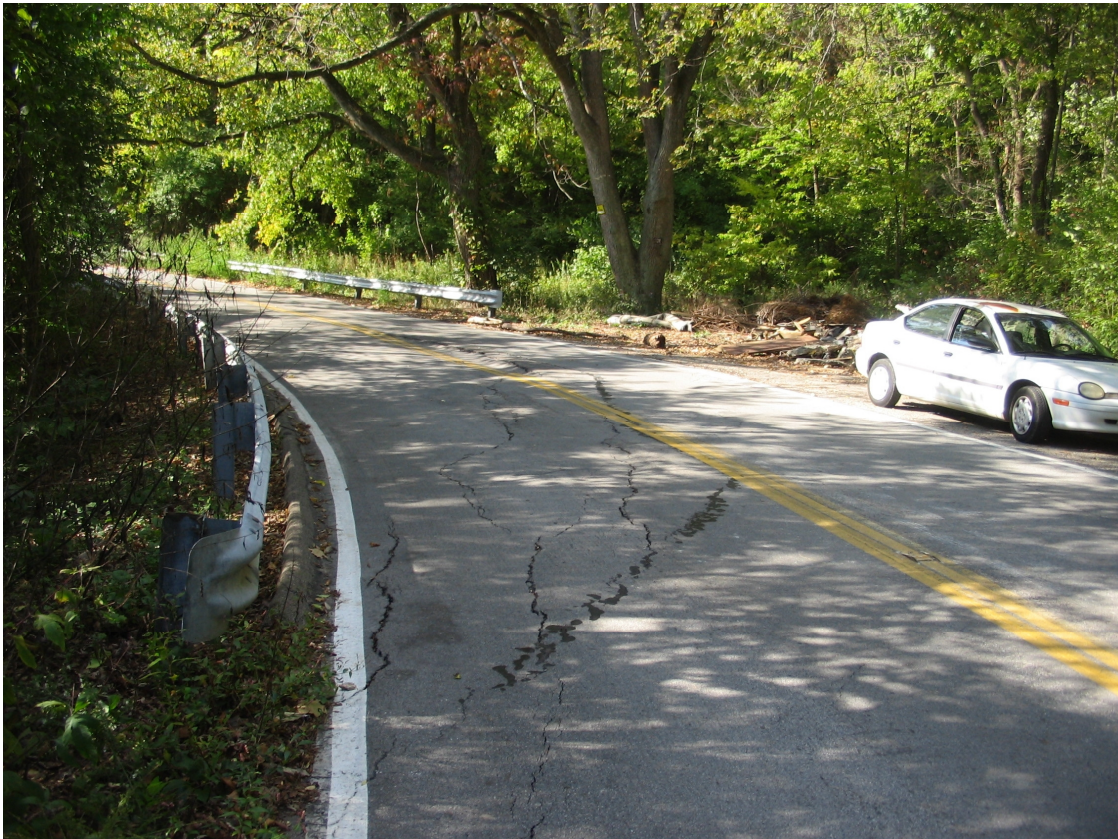
A landslide exists within Hillside Avenue east of its intersection with Tyler Avenue. The headscarp of the landslide is within Hillside Avenue and extends westward into Tyler Avenue. Vertical offset along the headscarp requires continued maintenance to level the pavement and the sealing of tension cracks in order to prevent the infiltration of surface water into the subsurface. The pavement condition and ride quality are in critical condition due to continuous damage caused by movement of a landslide. Permanent pavement repair cannot be performed until the landslide is stabilized. A subsurface investigation indicates the slip surface is at the top of rock which varies from twelve to thirty feet below the existing ground surface.

Hillside Avenue east of Tyler. Note sealing of tension cracks in roadway.

A 48 inch sewer line runs perpendicular to the slope and is located within the landslide. A twelve inch water main is located within Hillside Avenue at the edge of the pavement

of the inbound lane. Continued movement of the landslide will eventually affect the integrity of the utilities. A break of any of these utilities will cause the introduction of water into the landslide which could lead to a sudden a drastic movement requiring emergency closure of the road.

The City is in the process of accepting ownership of the foreclosed property below the roadway at 3891 Hillside Avenue. Stabilization of the landslide will be accomplished by grading the slope below Hillside Avenue and the construction of an earth buttress on this property. This buttress fill solution is more cost effective then building a wall.

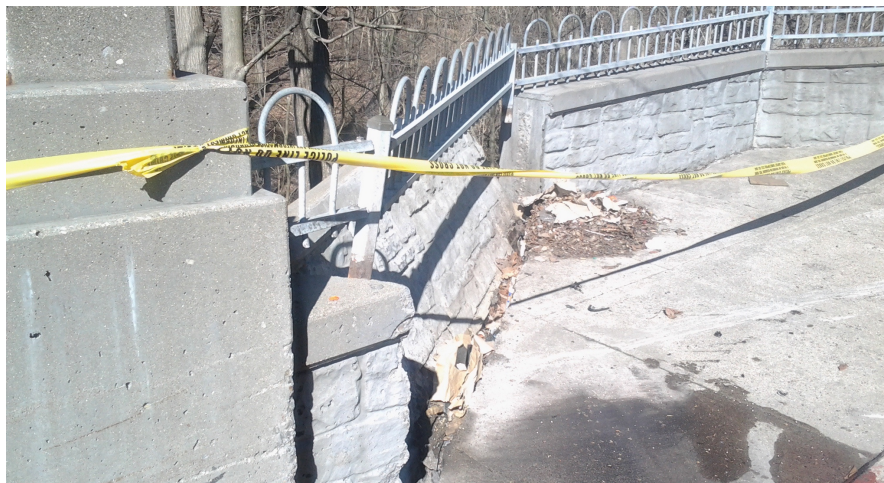
Automobile Accidents have damaged two sections of the retaining wall on the west side Colerain Avenue. The damaged sections are opposite Tranquility Lane and Raeburn Drive. Both locations are bus stop pad indents in the mile long wall. The repair is expected to be completed by TROD in the spring of 2016.

Damaged Colerain Avenue retaining wall opposite Tranquility Lane.

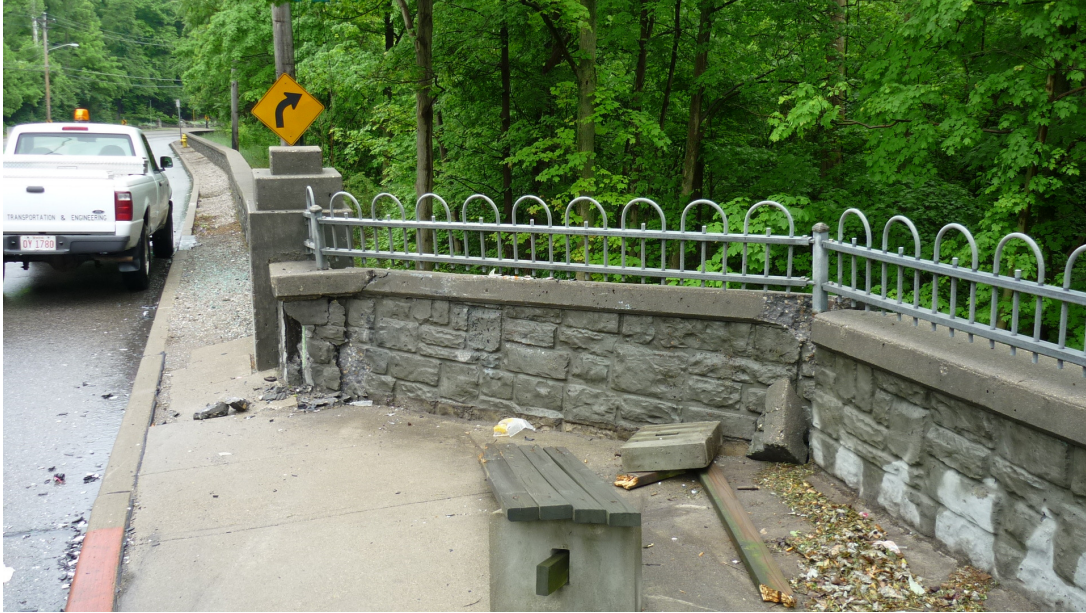
Damaged Colerain Avenue retaining wall opposite Raeburn Drive.

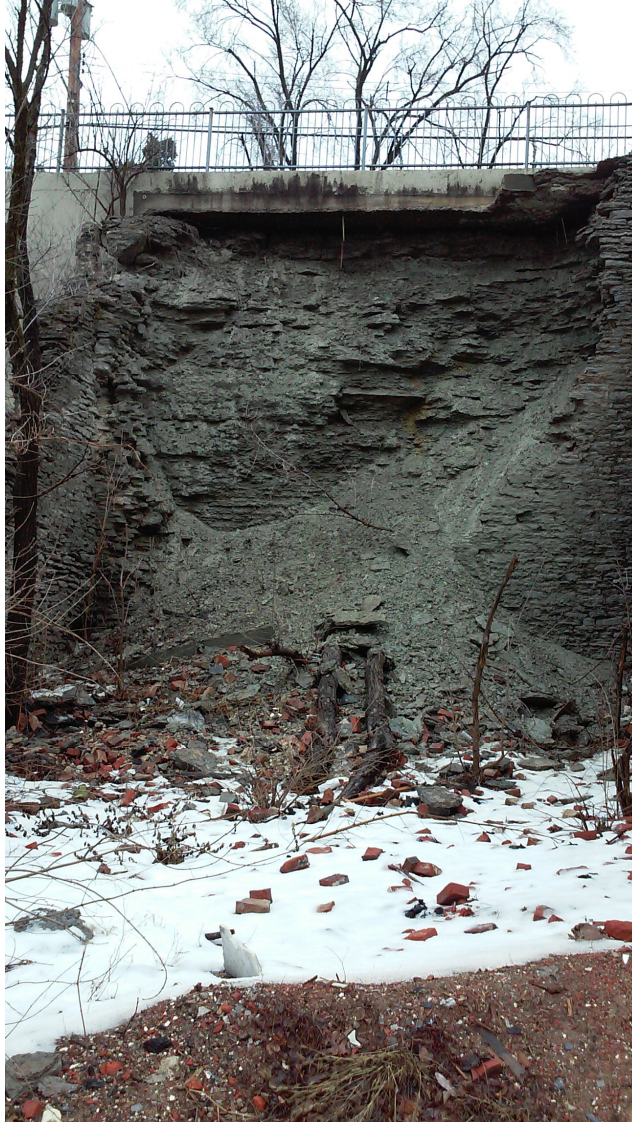
The sidewalk on the south side of Dorchester Avenue had to be closed in 2012 due to ongoing undermining. This undermining began when a stone wall which originally served as a foundation for a structure along Sycamore Street partially collapsed. Building and Inspection has been unsuccessful in determining ownership and responsibility of the original stone wall failure. In order to reopen the sidewalk, a precast large block segmental wall will be constructed in front of the remaining portions of the stone wall. The proposed wall will protect the remaining portion of the wall from further damage and support the walk on Dorchester Avenue. The proposed wall acts primarily as a facing for a relatively stable bedrock cut. Future redevelopment of the parcel will likely involve constructing a new foundation wall as close to the Dorchester right-of-way as possible. This future wall would replace the function of the proposed segmental wall, allowing the blocks to be removed and repurposed by the City. Ownership of the parcel is now with the National Foundation for Community Partnership, Inc. Real Estate is in the process of obtaining a legal agreement that would allow the City to place the block wall on a temporary easement in the private property.

View of Dorchester Avenue from below on Sycamore Avenue. Note undermining of Dorchester wall cap and sidewalk. Shale and limestone bedrock exposed in face of slope.

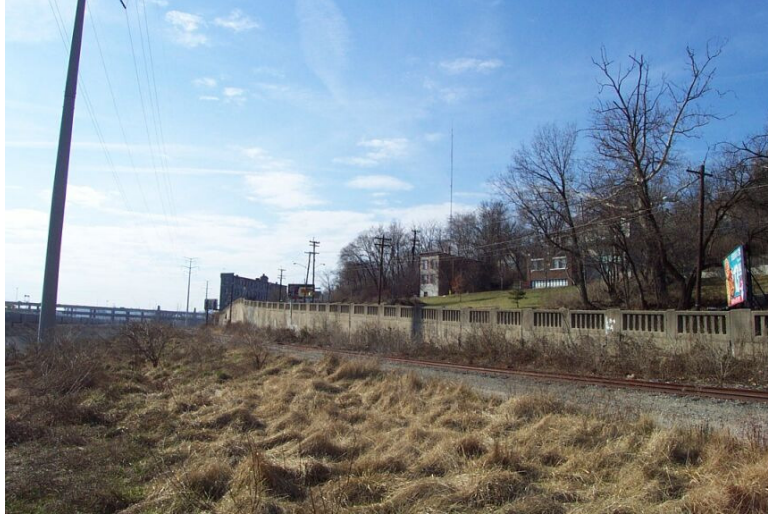
The existing retaining wall is in fair condition, the coping which is attached to the wall and the concrete railing which is attached to the coping is in a failed critical condition. Sections of the railing have deteriorated, exposing reinforcing steel. Sections of the railing which appear visually sound crumble within a grasp of the hand. Soundings indicate that the majority of the railing is not sound. Even if sound, the existing railing does not meet crash standards. Applications for SCIP assistance were submitted in 2008 and 2009 but the project was not funded. Guardrail sections have been bolted to the pilasters throughout the years to temporarily repair the railing.

Southern portion of Cummins Street retaining wall from below.

The existing concrete railing and coping needs to be replaced with a Texas Style railing by doweling into the existing retaining wall. The installation of the new concrete railing will require the removal and replacement of the curb. The existing retaining wall is in fair condition and requires removal of disintegrated concrete down to sound concrete and replacement of concrete removed. Soundings revealed approximately 2,000 square feet of unsound concrete. Joints between the panels need to be reconstructed and the entire wall will need to be sealed. The repairs to the retaining wall are essential in order to avoid complete replacement of the retaining structure. Pavement repair is limited to that disturbed due to the excavation for the installation of the concrete railing.

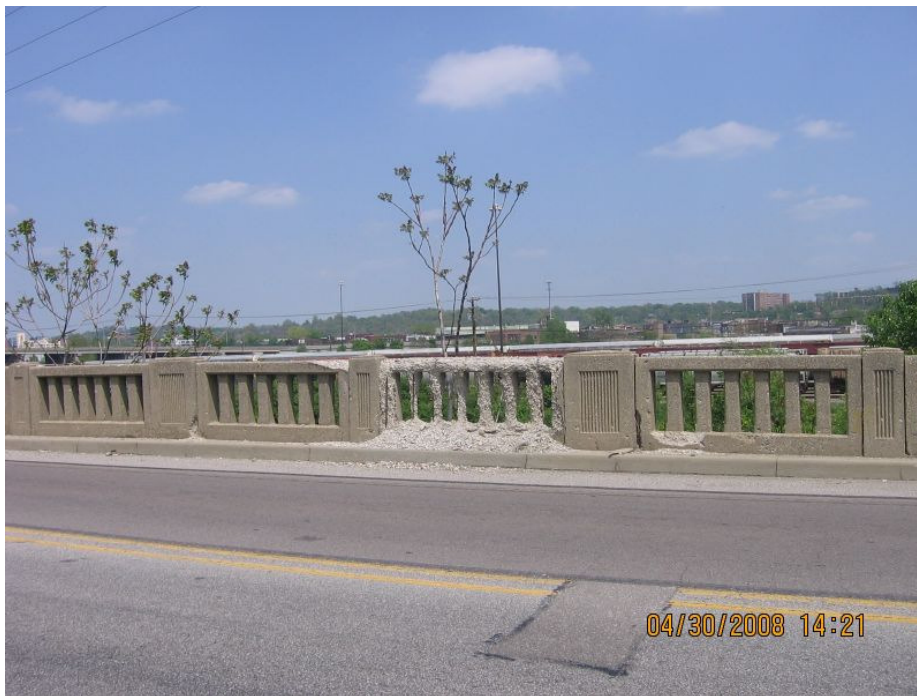
Disintegration of railing exposing steel reinforcement most likely due to salt spray.

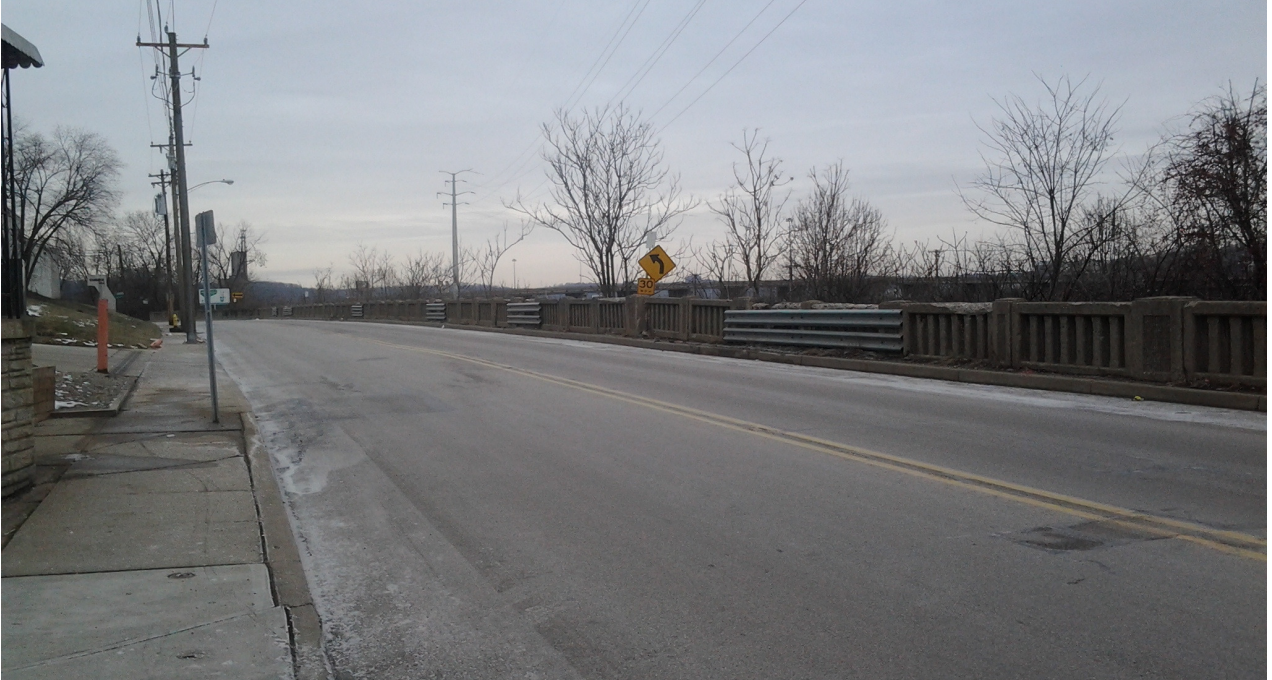
Sections of concrete railing replaced with guardrail sections bolted to pilasters on Cummins Street.

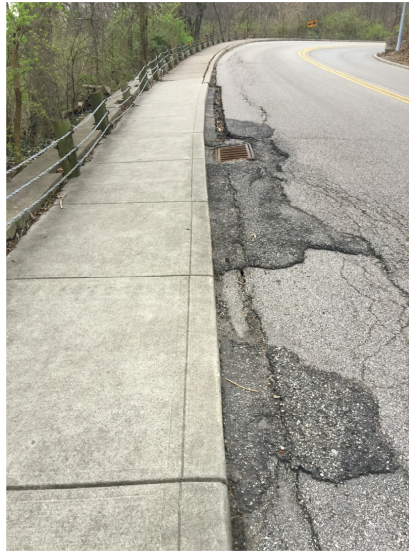
Hillside movement affects Art Museum Drive for a distance of approximately 500 feet from its intersection with Eden Park Drive. The existing retaining wall constructed in the 1930's is founded within the overburden and is moving down slope within a slow moving slide mass. The movement has caused separation of the sidewalk from the curb, separation of the curb from the roadway and tension cracks within the pavement.

The roadway has an asphalt pavement surface which was resurfaced in 2006. Repairs were also made at this time to the existing sidewalk which contained numerous offsets of individual blocks due to tilting of the slabs. Repairs made in 2006 have since been damaged by the movement. Pavement patching has been performed throughout the years. Additional pavement repair will be required until the landslide is stabilized. A significant number of the wooden guardrail posts are rotted. Sections of the existing wall cap are deteriorated.

Patchwork to fill gaps due to hillside movement between curb and pavement.

The preliminary subsurface investigation indicates that the movement is occurring at the top of rock which is at a depth of approximately 12 feet below the existing ground surface. Stabilization of the landslide could be accomplished by the installation of a drilled pier retaining wall. The piers would be located on the downhill side of the existing retaining wall and consist of twenty-four (24) inch diameter piers spaced on a center to center spacing of eight feet. A wall cap will be installed on top of the piers to connect and buttress the existing retaining wall to the piers eliminating the need for the installation of panels between the piers. The cap of the existing retaining wall would

also be repaired where required. The existing cable guardrail would be replaced with a different guardrail system, most likely a steel backed timber guardrail. The existing pavement of the roadway would be repaired within the limits of the pier wall.

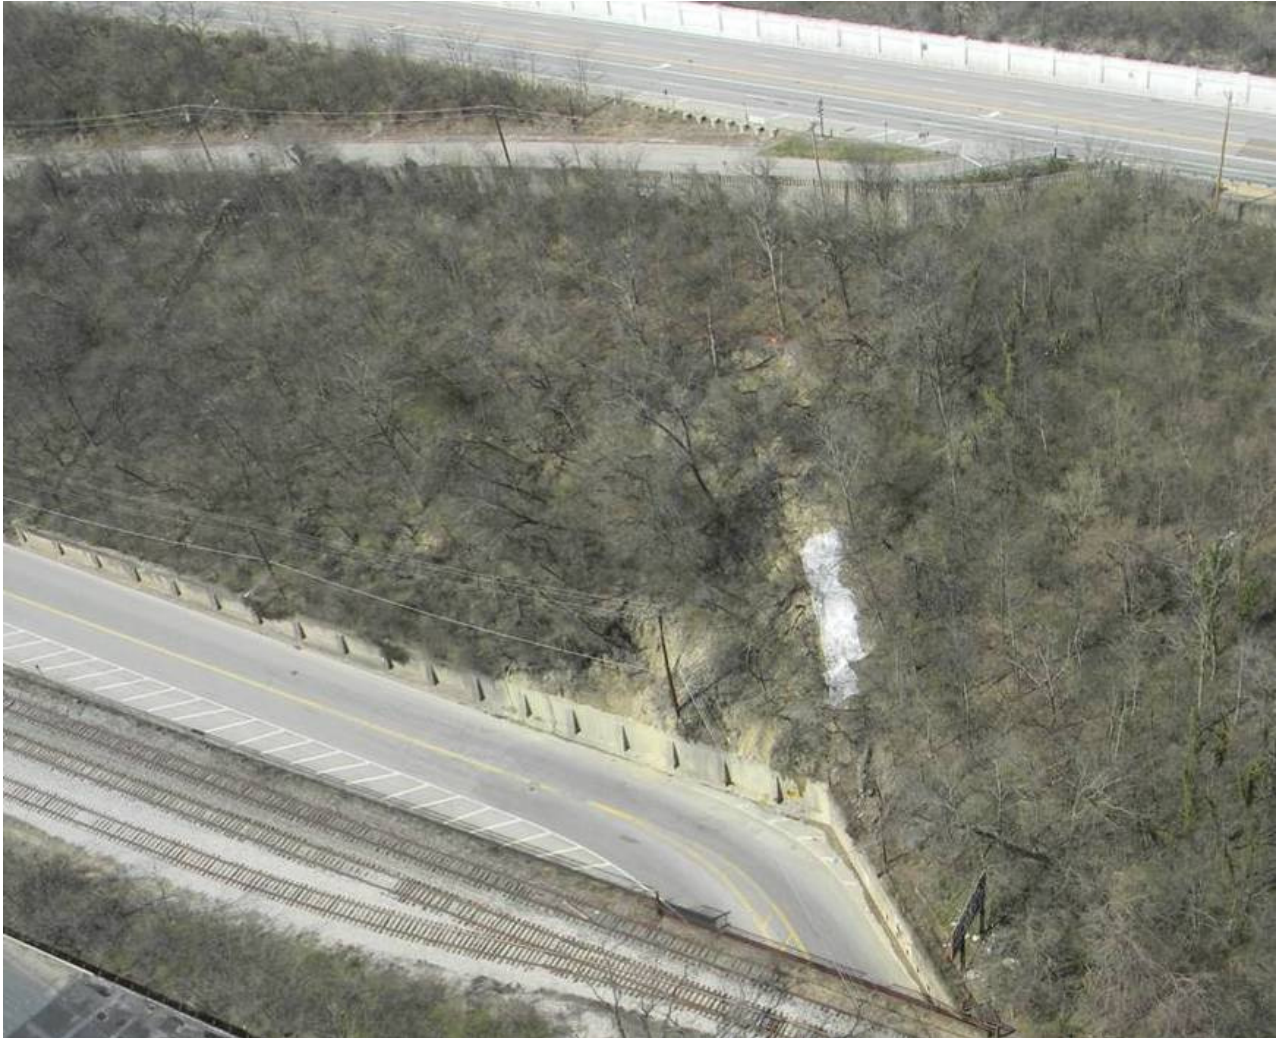
A landslide occurs above the existing retaining wall on the north side of Riverside Drive, US Truck Route 50, immediately west of the Rookwood Railroad Overpass. It extends up the hillside to immediately below Kemper Lane and Columbia Parkway US Route 50. The slide area covers nearly 1.5 acres of hillside. Riverside Drive, US Truck Rt. 50 is one lane in each direction through the Rookwood Overpass. The road curves as it goes under the overpass. West bound traffic is blind to debris which topples over the wall onto the roadway.

Hillside creep and some small flow of debris have overtopped the wall at Riverside Drive for years. Significant movement has not occurred since the spring seasonal rains of 2011. Significant massive acceleration of the landslide however may occur which could result in the entire slide mass overtopping the retaining wall as a debris flow completely covering the road. Water continues to seep over the wall for extended periods of time following rain events, creating hazardous conditions, particularly during freezing weather.

Aerial view of landslide on Riverside Drive west of the Rookwood Overpass. The property above the wall is owned by the Park Board. Note extent of headscarp. Plastic sheet left behind after test pits were dug in 2011 to prevent water from seeping along scarp line into the slide mass. Plastic has since deteriorated and no longer exists.

the piers at a depth of 6 ft. below the tops of the piers. The estimated total length of drainage ditches to divert surface water away from the landslide is 1,000 feet. The drainage ditches will outlet into a ditch inlet and be piped to existing storm sewer lines.
