**W M O U N T
W A S H I N G T O N**
**A R C H I T E C T U R A L
F O C U S S T U D Y**

pamss
room 141 city hall
cincinnati, ohio 45202
513-352-3441

ARCHITECTURAL FACADE STUDY

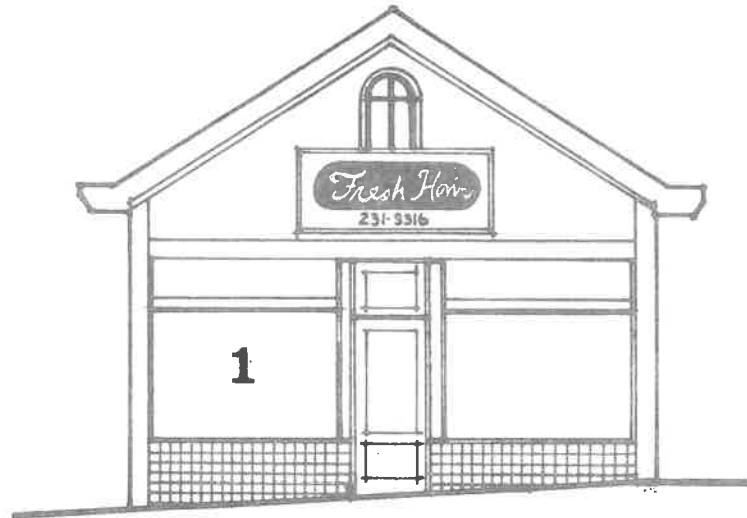
Business Fresh Hair
Address 1963 Mears Avenue
Ownership Owner Occupied

- 1** Additional pedestrian scaled window graphics

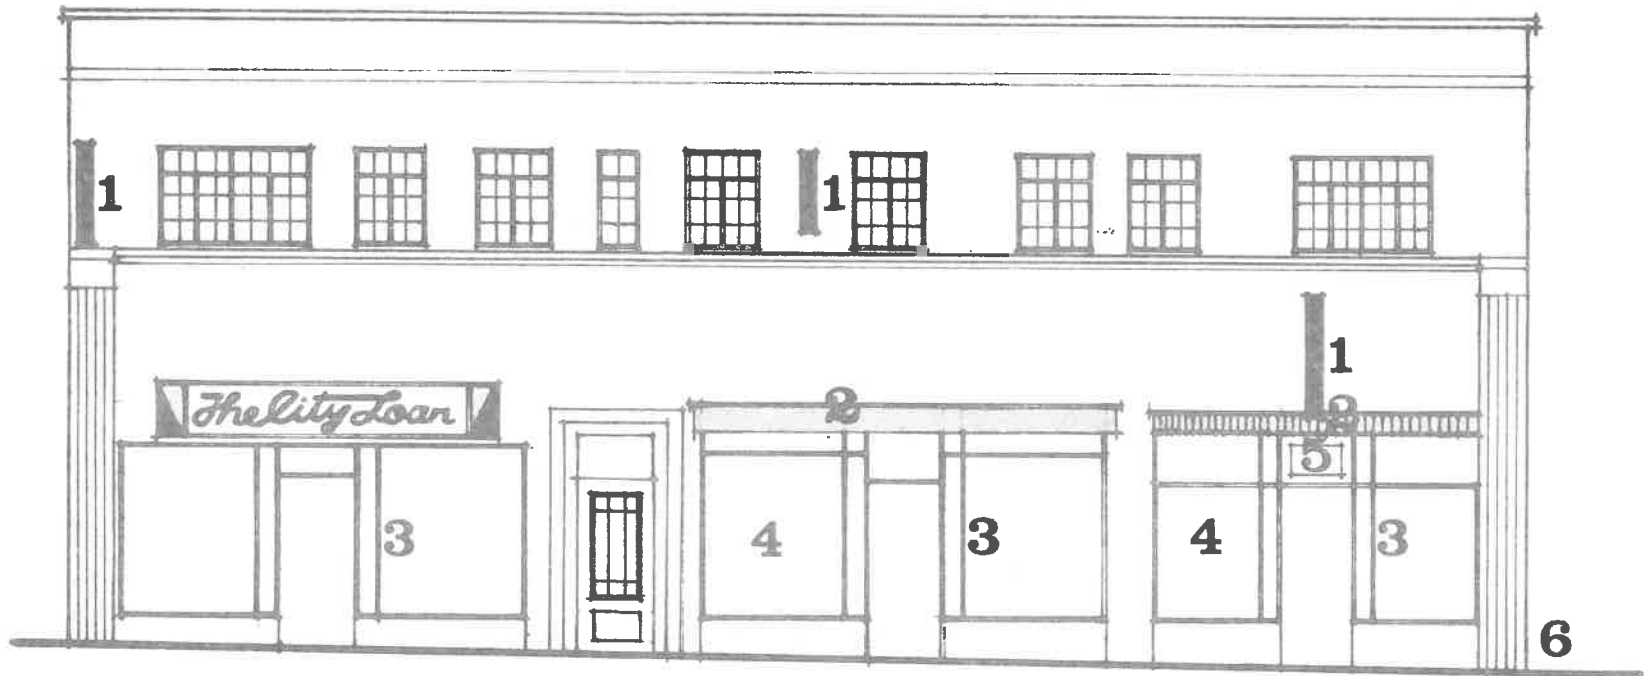
Business City Loan - Muller's Shoes - Kay Hew Office Supplies
Address 2061 Beechmont Avenue
Ownership Lease - Owner Occupied - Lease

- 1** Remove projecting signs - replace with surface mounted signage
- 2** Replace awning fabric - remove end panels
- 3** Improve storefront trim and door - paint or replace
- 4** Pedestrian scaled window graphics
- 5** Screen air-conditioning unit
- 6** Rear entrance possibilities

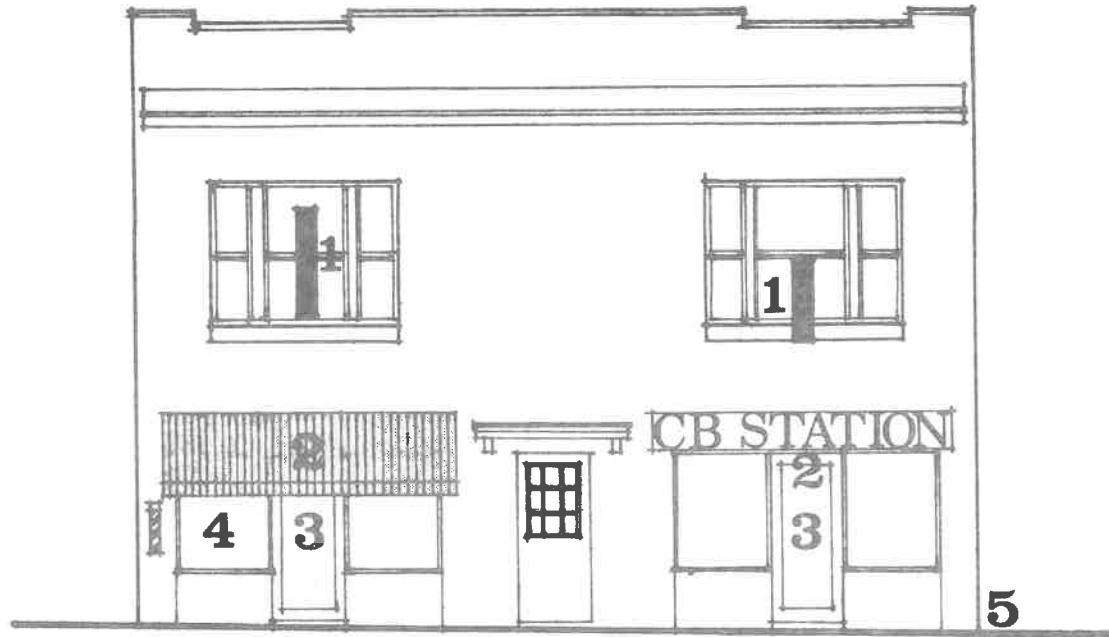
Business Beechmont Barber Shop - CB Station
Address 2065 Beechmont Avenue
Ownership Lease - Rent

- 1** Remove projecting signs
- 2** Remove end panels on awning
- 3** Improve storefront trim and door - paint or replace
- 4** Pedestrian scaled window graphics
- 5** Rear entrance possibilities

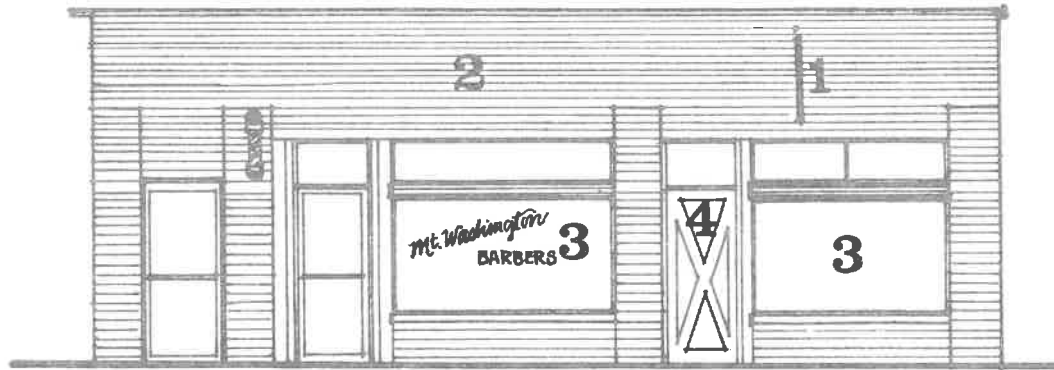
Business Mt. Washington Barbers, The Hair Barette
Address 6135, 6127 Corbly
Ownership Lease, Owner Occupied

- 1** Remove projecting sign
- 2** Improve facade material
- 3** New pedestrian scaled window graphics
- 4** Replace door

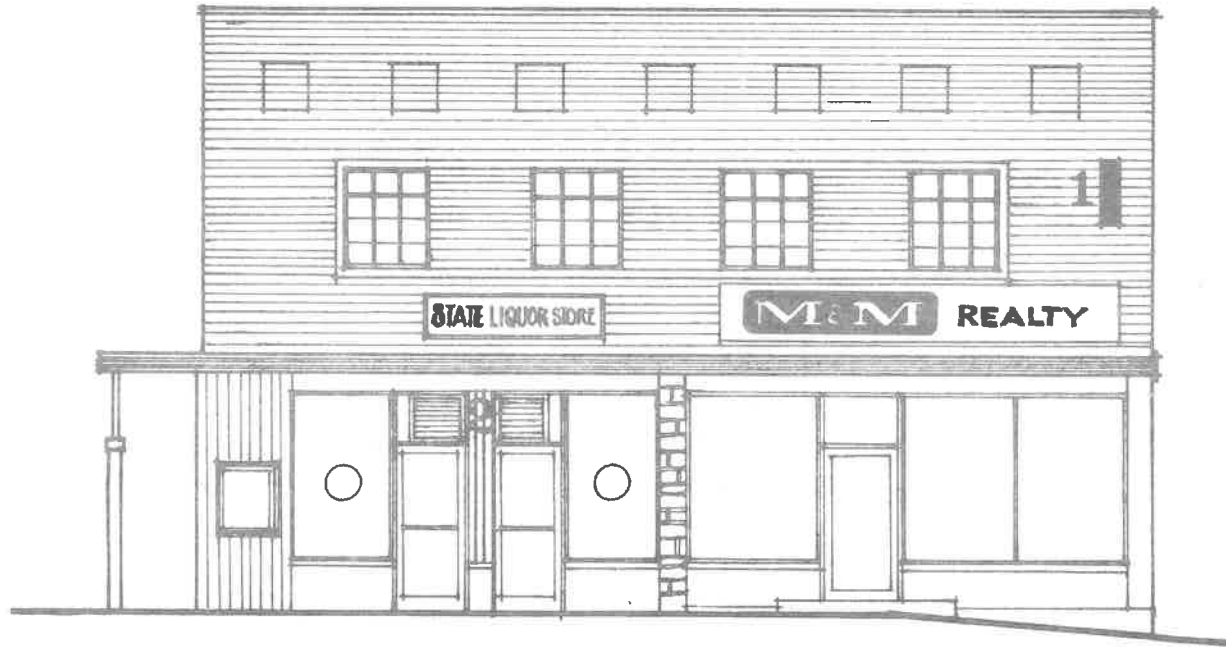
Business State Store - M & M Realty
Address 2219, 2221 Beechmont Avenue
Ownership Unknown - Lease

- 1** Remove projecting sign
- 2** Screen air-conditioning units

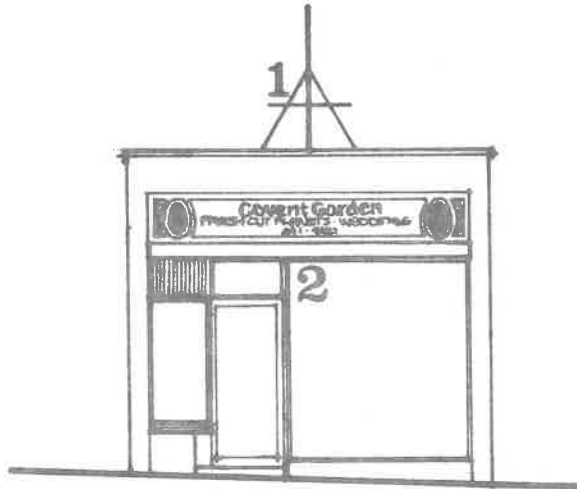
Business Covent Gardens
Address 2223 Beechmont Avenue
Ownership Lease

- 1** Remove projecting sign structure
- 2** Improve storefront trim - paint or replace

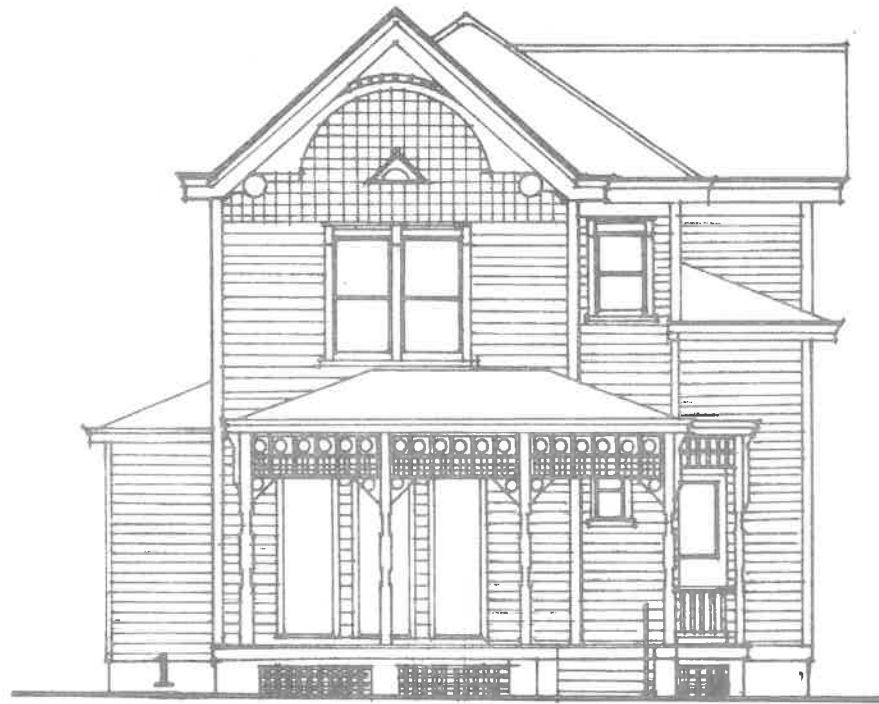
Business Bona Decorative Hardware and Moldings
Address 2227 Beechmont Avenue
Ownership Owner Occupied

- 1 Additional site landscaping

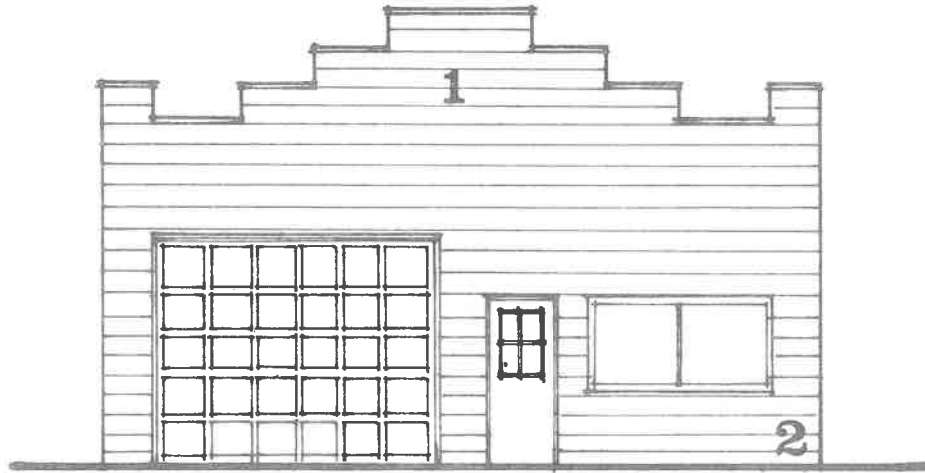
Business Mt. Washington Motors
Address 2243 Beechmont Avenue
Ownership Rent

- 1** Paint building graphics incorporating signage
- 2** Clean up area - additional site landscaping

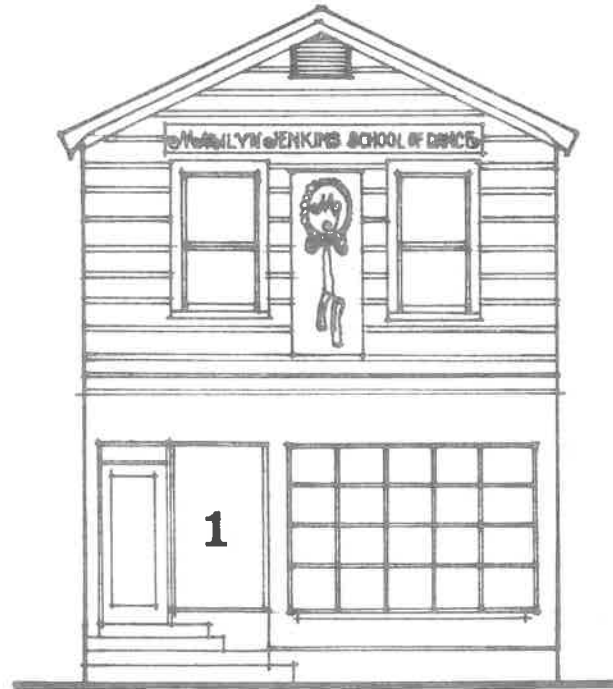
Business Marilyn Jenkins School of Dance
Address 2261 Beechmont Avenue
Ownership Unknown

1 Pedestrian scaled window graphics - address, phone number

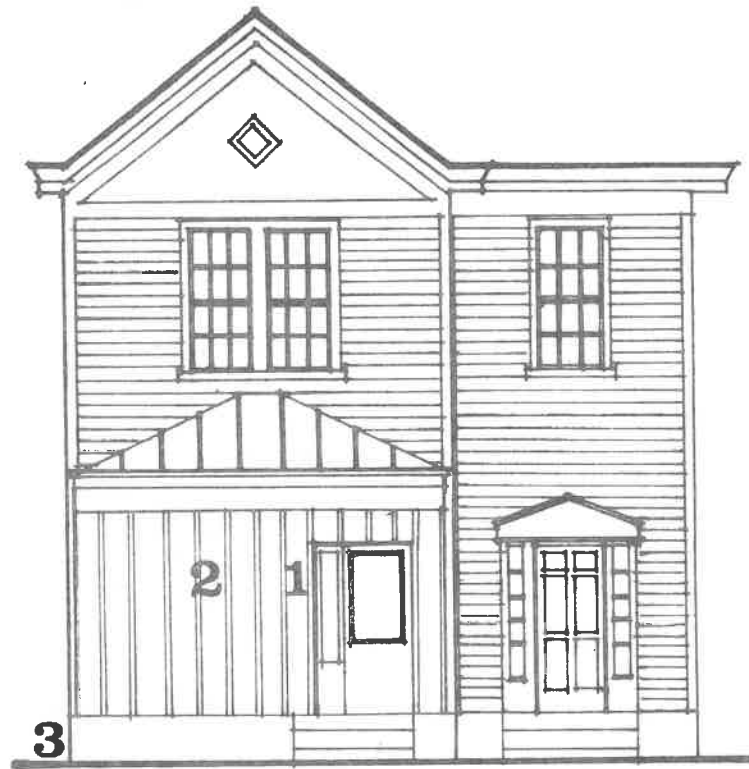
Business Vacant
Address 2250 Beechmont Avenue
Ownership N/A

- 1** Paint trim and door
- 2** Rework commercial facade of building
- 3** Rear entrance possibilities

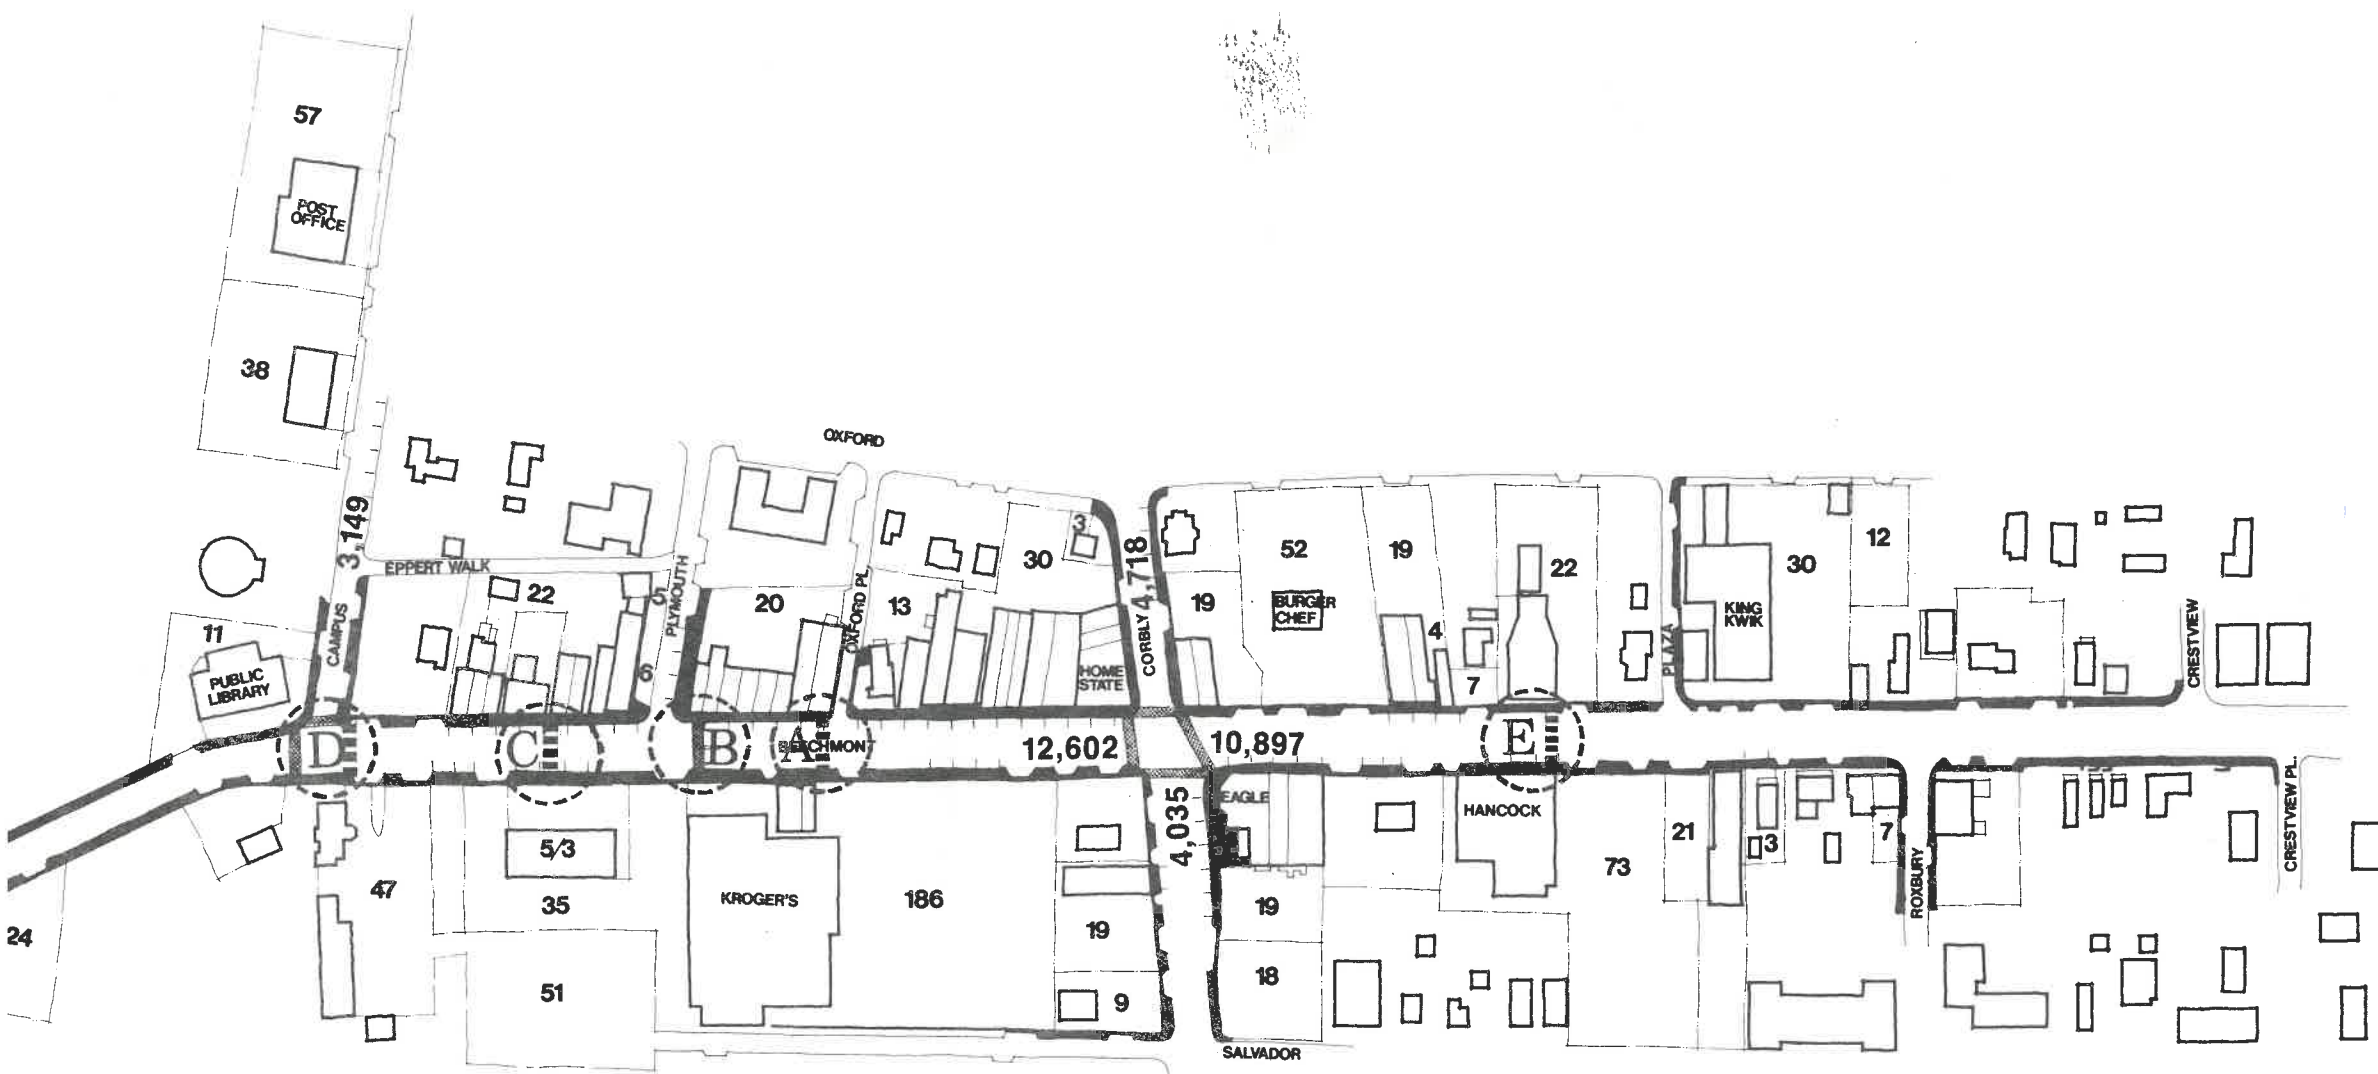
Crosswalk Realignment Map

- A New Crosswalk - 1st Priority
 - B Remove Existing Crosswalk
 - C New Crosswalk - 2nd Priority
 - D New Crosswalk - 3rd Priority
 - E New Crosswalk - 4th Priority
- 8,633 Traffic Counts

4. Realign marked crosswalk on Beechmont relating to the parking lot and entrance of the new Kroger Store and the pedestrian way with special amenities, i.e., lighting, trees, benches, paving, trash receptacles, etc. Parking entrances for Blocks B and C could then be diverted to Plymouth, Corbly, and Oxford and eliminate the difficult entrance to Beechmont from Oxford Place.
5. If a greater need presents itself, add a mid-block crosswalk connecting the Fifth Third Bank and Block A. Also, an additional crosswalk at Campus Lane and White's Funeral Home if demand exists.
