# DORIS DAY DOG PARK RENOVATIONS & IMPROVEMENTS

2970 WESTWOOD NORTHERN BLVD, CINCINNATI, OH 45211

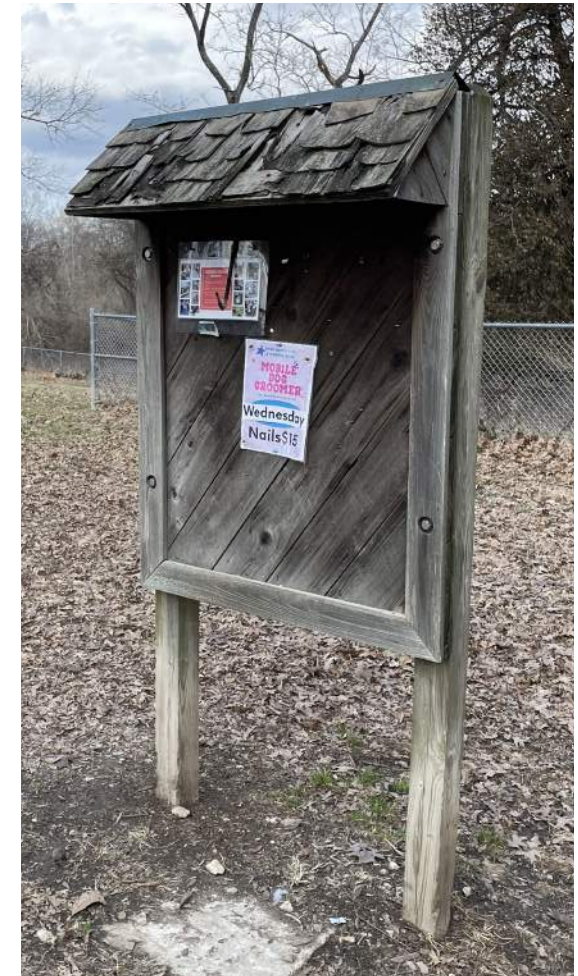
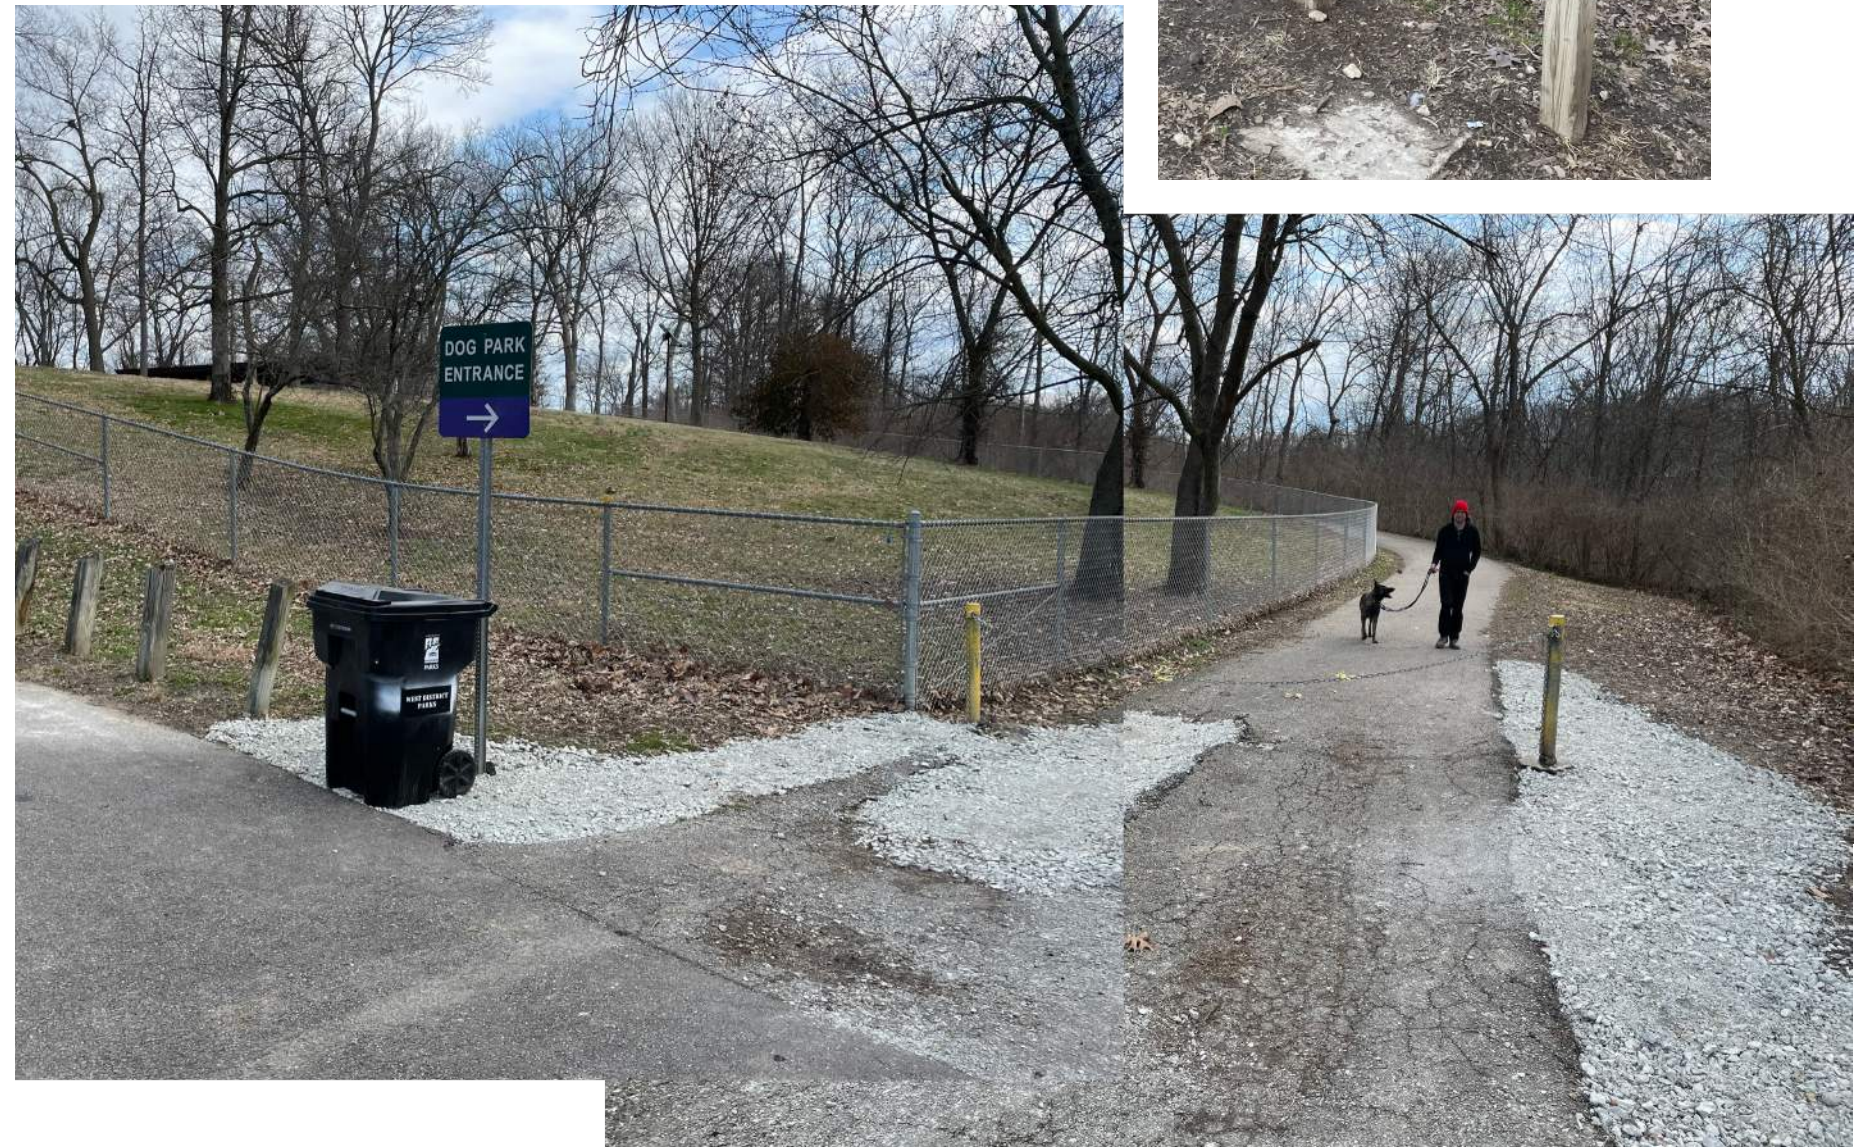
## INFRASTRUCTURE PROBLEMS

- Road/pathway to Dog Parks and Comfort Station is in severe disrepair and in need of remediation.
- Bollards at mouth of road are heavily damaged and blocking path of travel.
- Pathway would benefit from additional park-branded signage to post park/trail map and dog park rules, as well as provide additional spots for waste disposal bags.
- Signage in dog play areas no longer Parks standard.

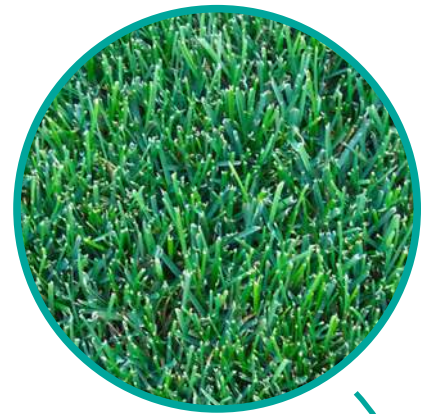
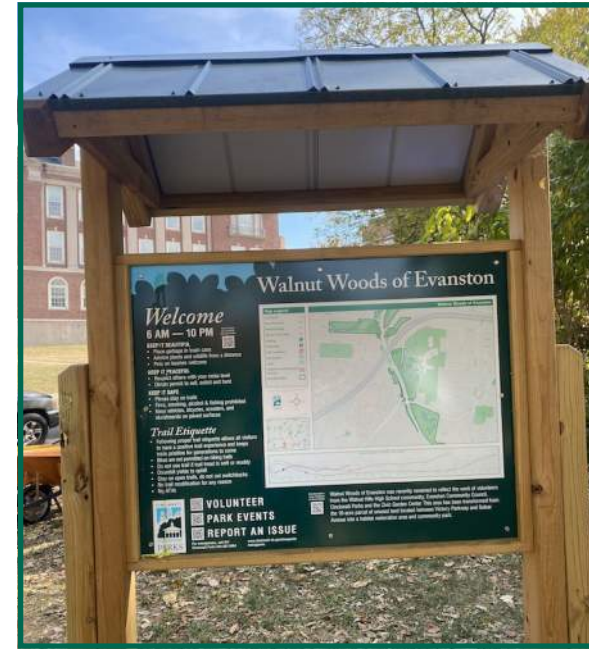
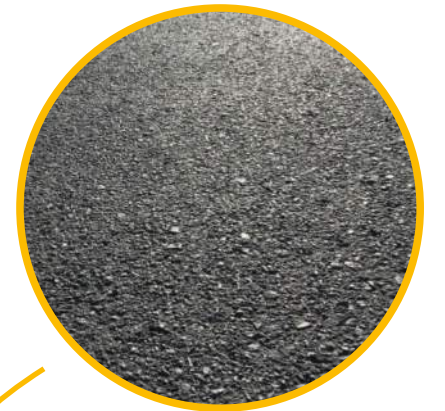
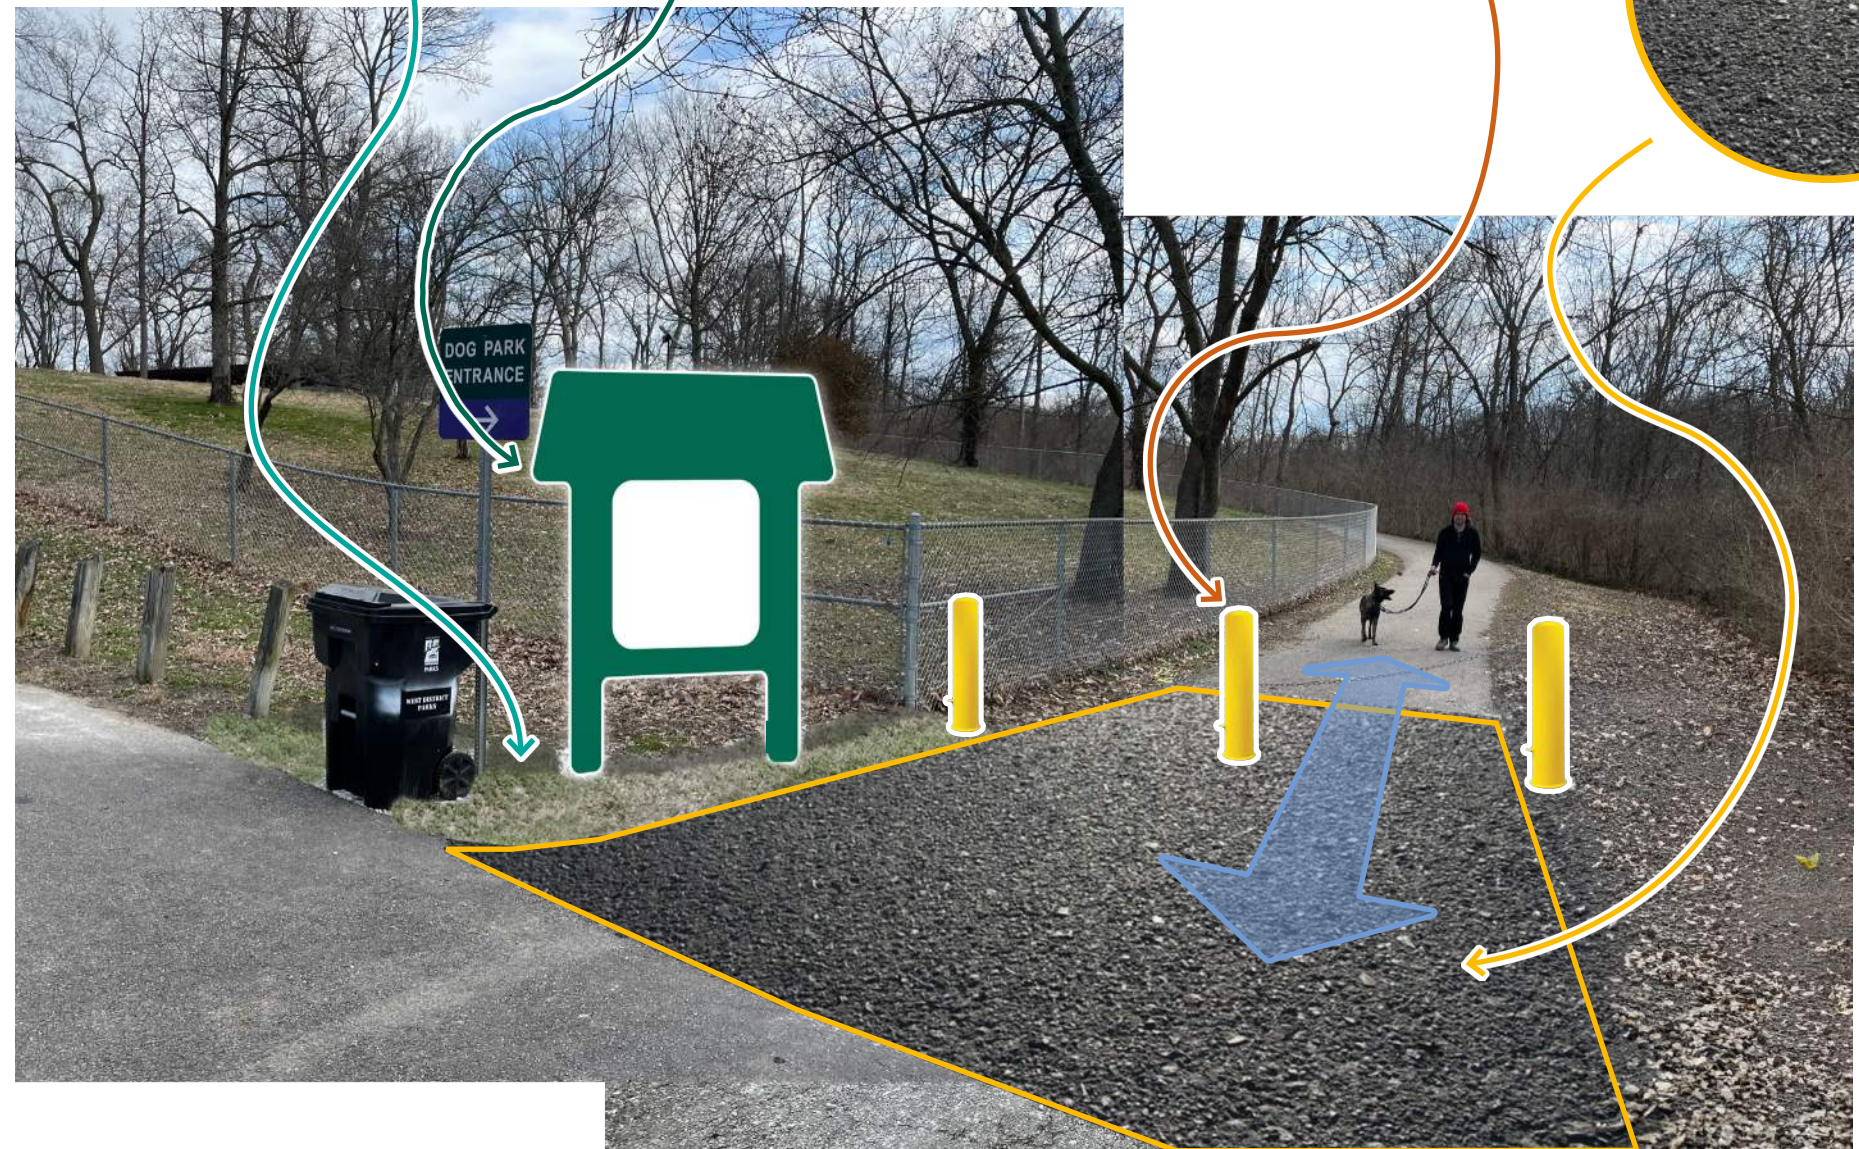
## IMPROVE SITE INFRASTRUCTURE

- Re-pave damaged pathway surface.
- Remove gravel topping and replace with appropriate sod or mulch (landscape potential).
- Install updated Parks signboard with park map and dog rules posted.
- Replace bollards and install middle removable bollard to allow travel along path, instead of around bollards.

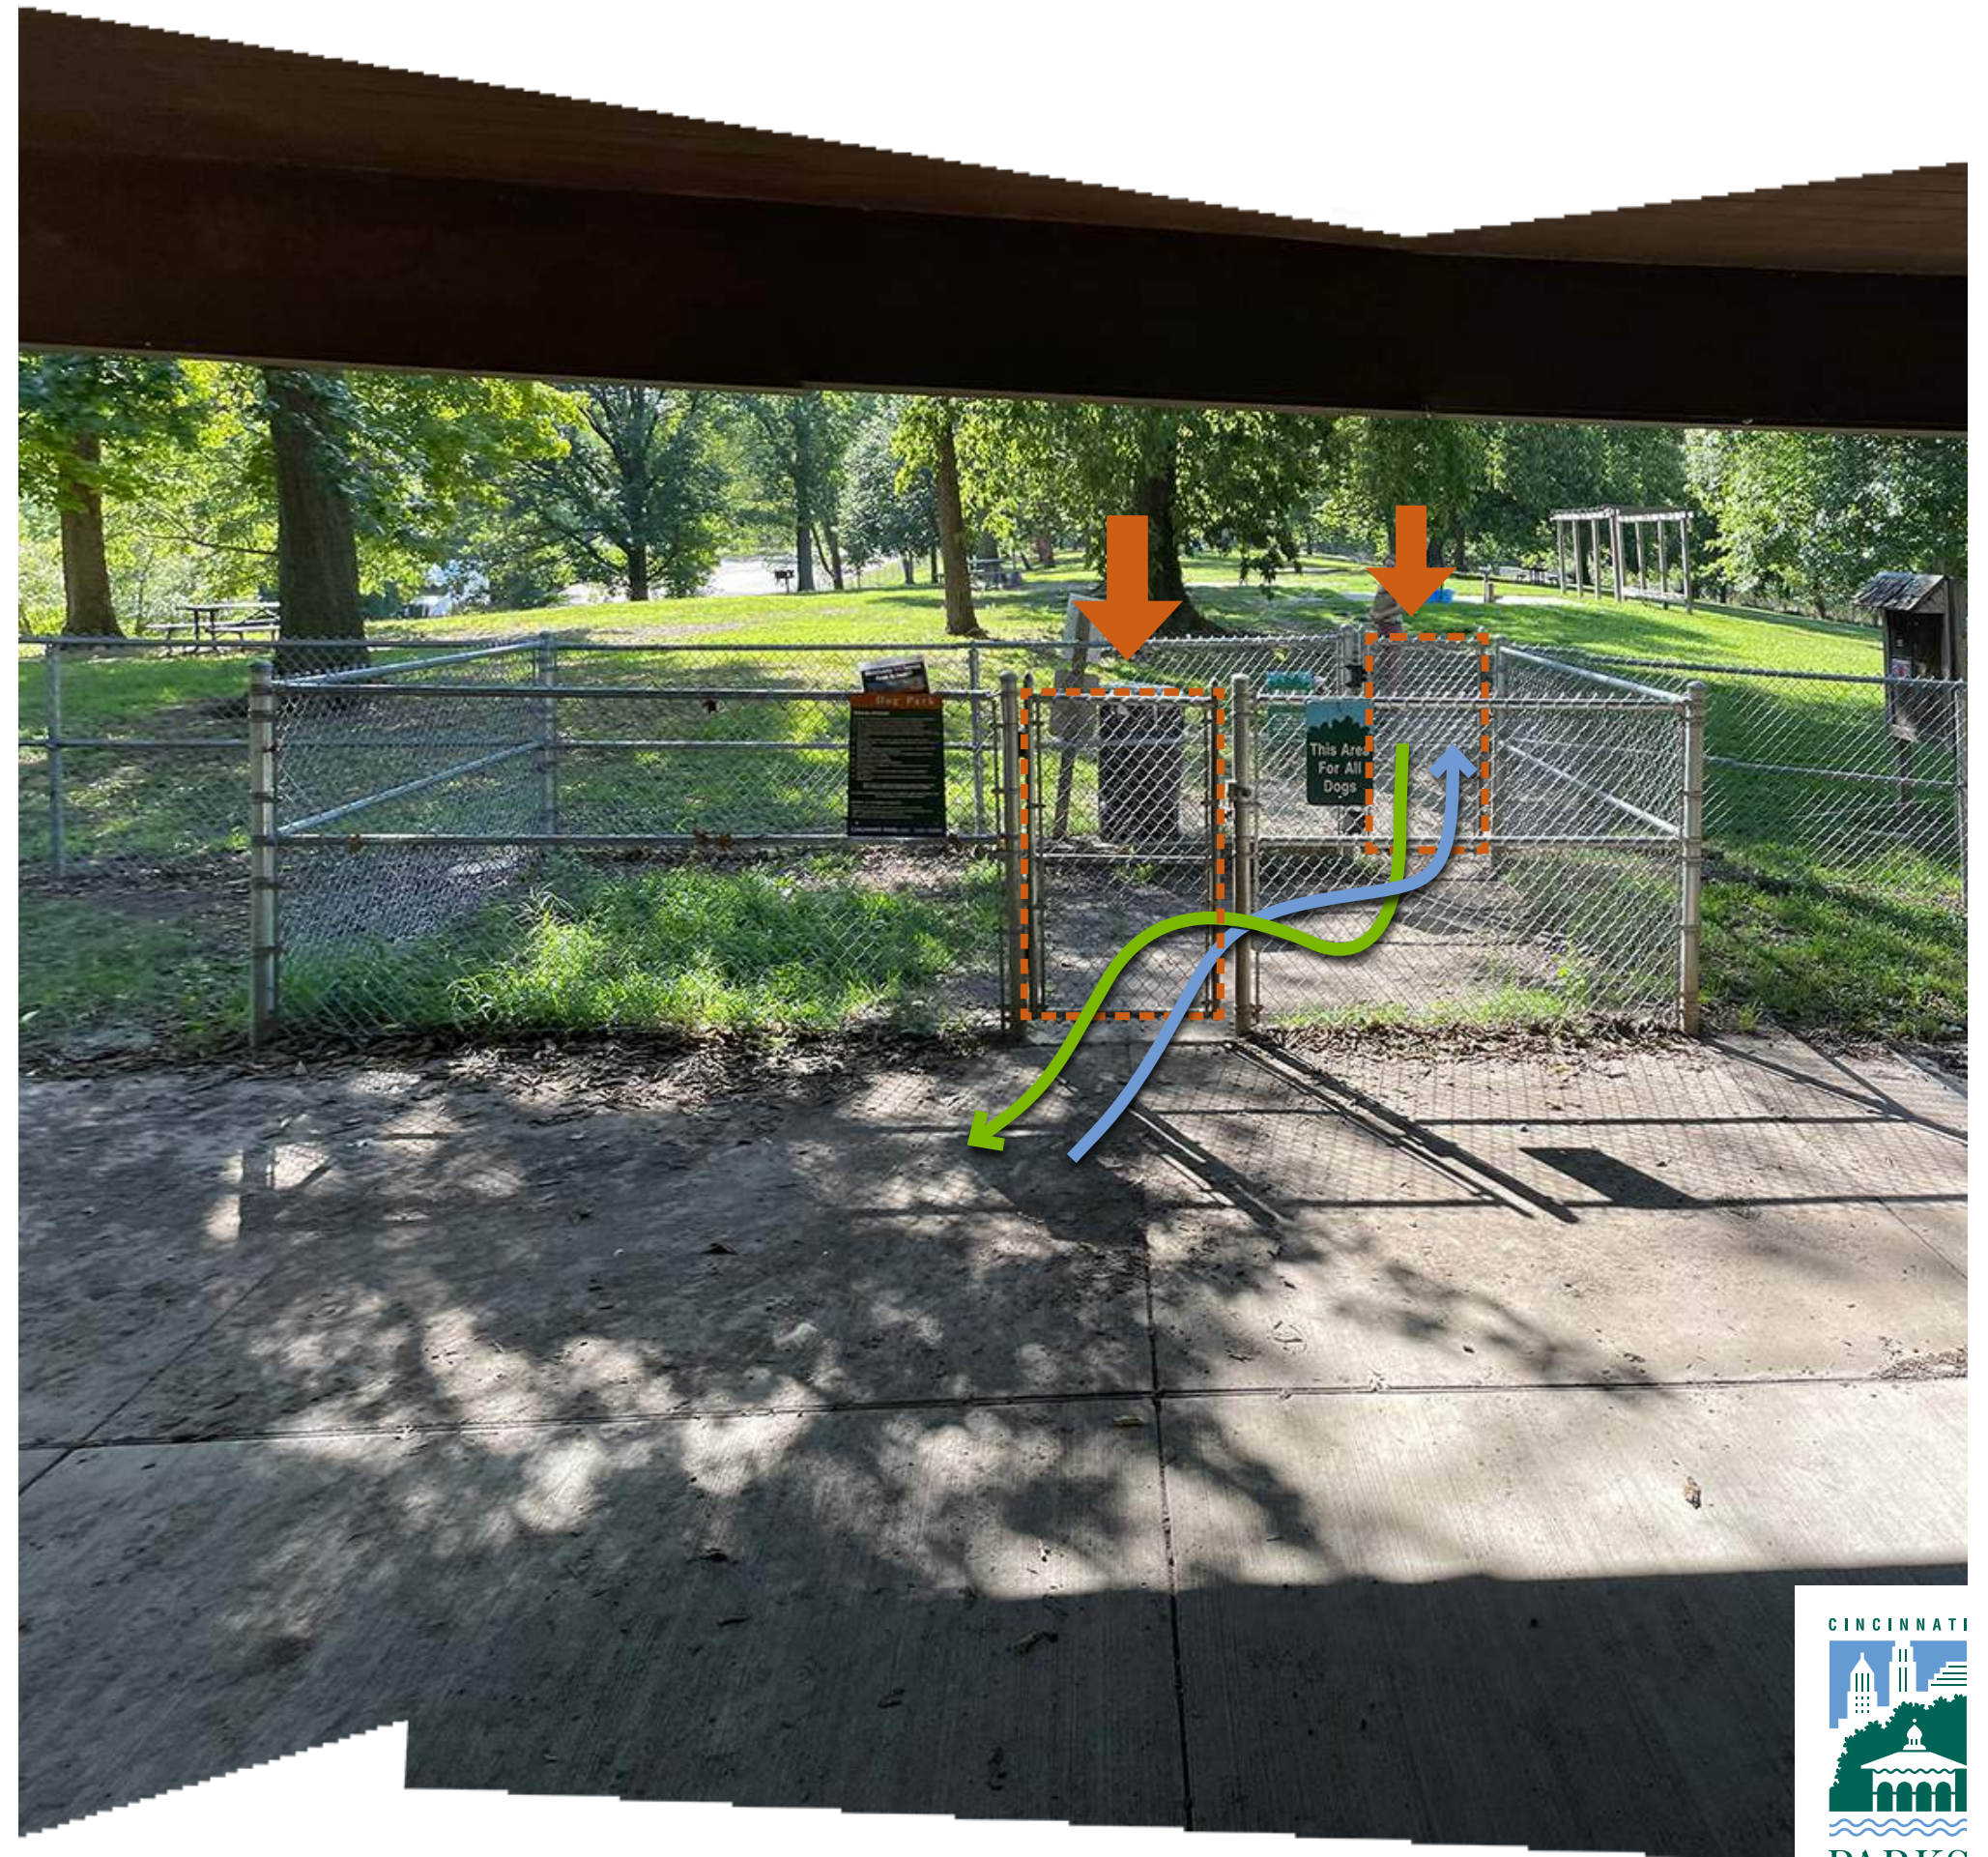
## DIFFICULT ENTRY / EXIT

- Only one “air-lock” or “vestibule” entry at both big and small dog areas  
(particularly a problem in the big dog area)
- This bottleneck can be hazardous for people entering and exiting, causing a “rush” of dogs in the fenced area at the gate when a new dog enters.
- Dirt/mud tracks into the vestibule, and can leave dogs dirty on their way back to their cars.

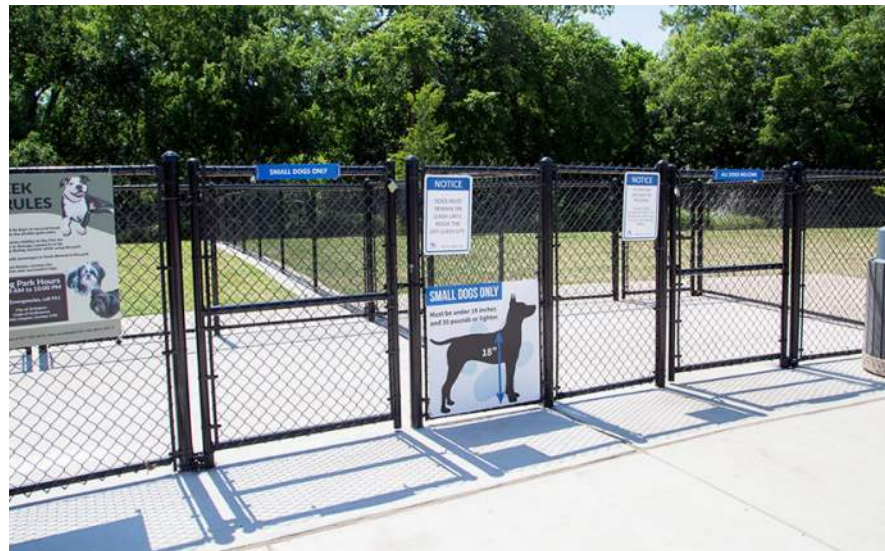
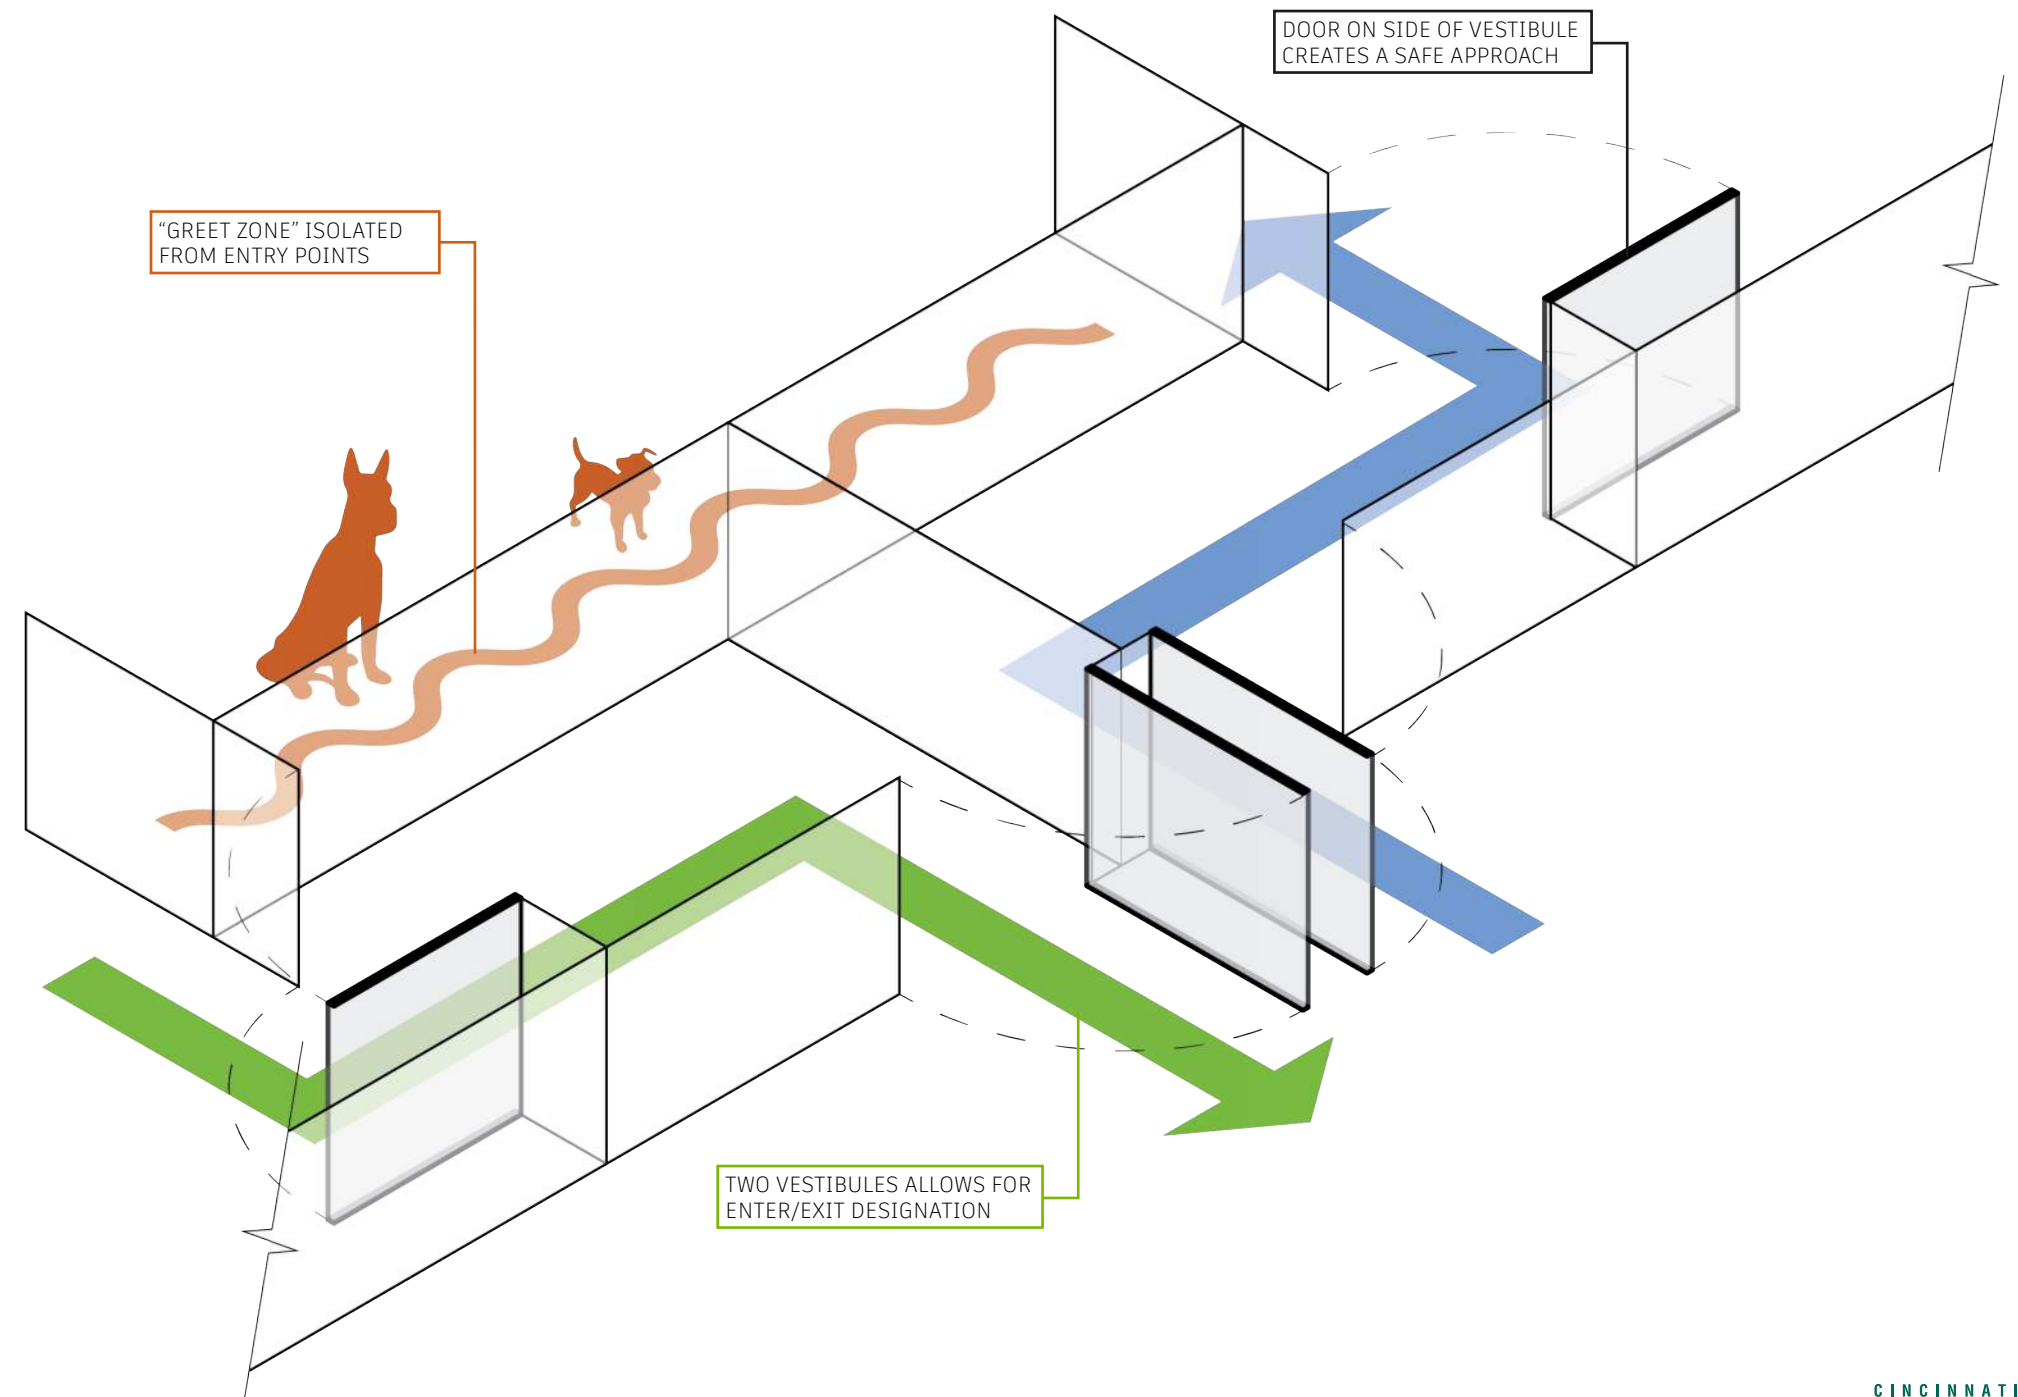
## NEW IMPROVED ENTRY

- Dual entry vestibules will give dogs and their people entering and exiting the park some respite.
- Entrances on the side of the vestibules allows for greeting dogs to gather at non-entry points.
- Greatly improves safety and flow.

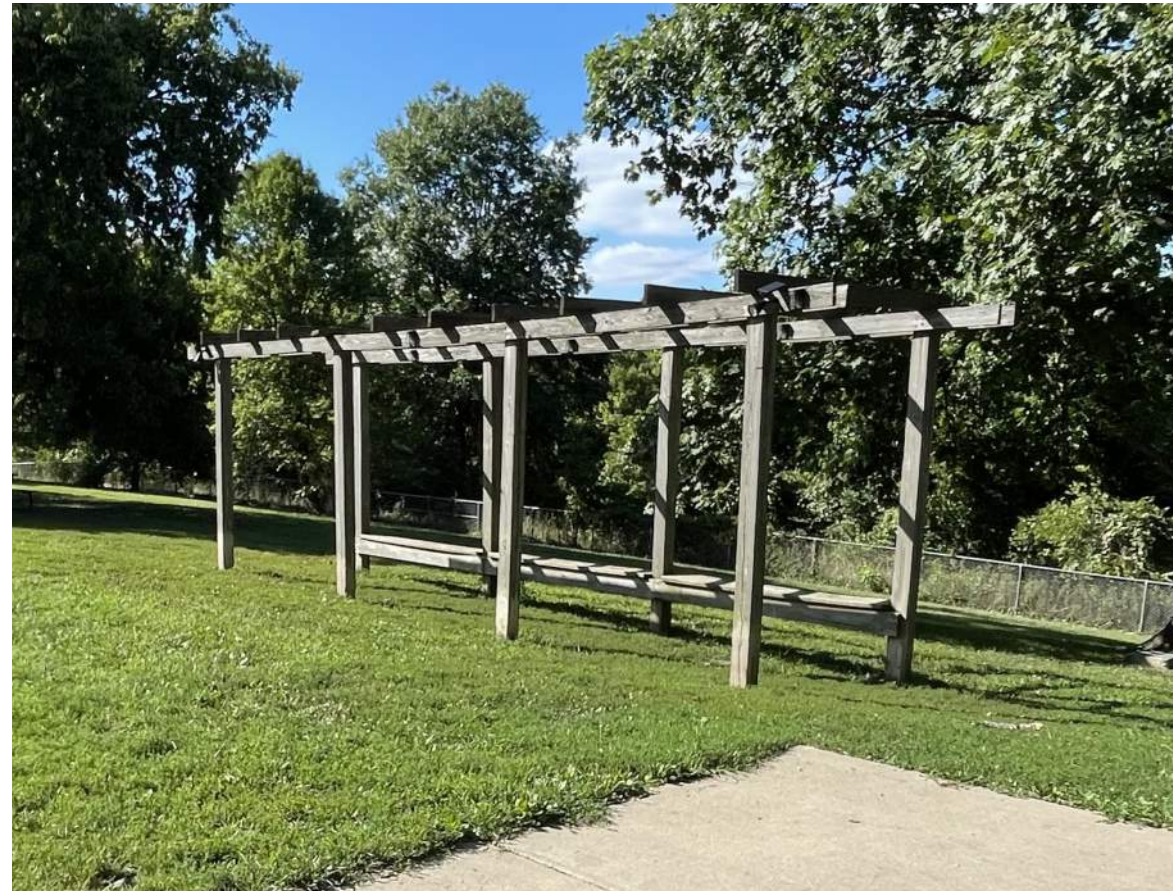
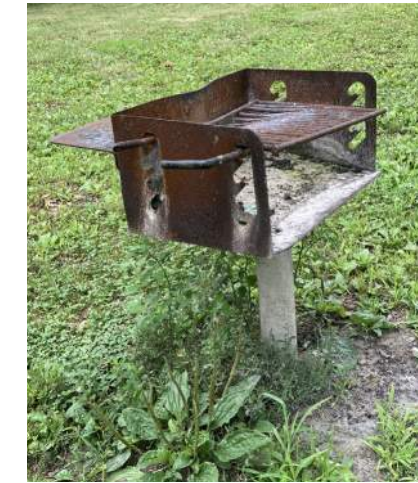
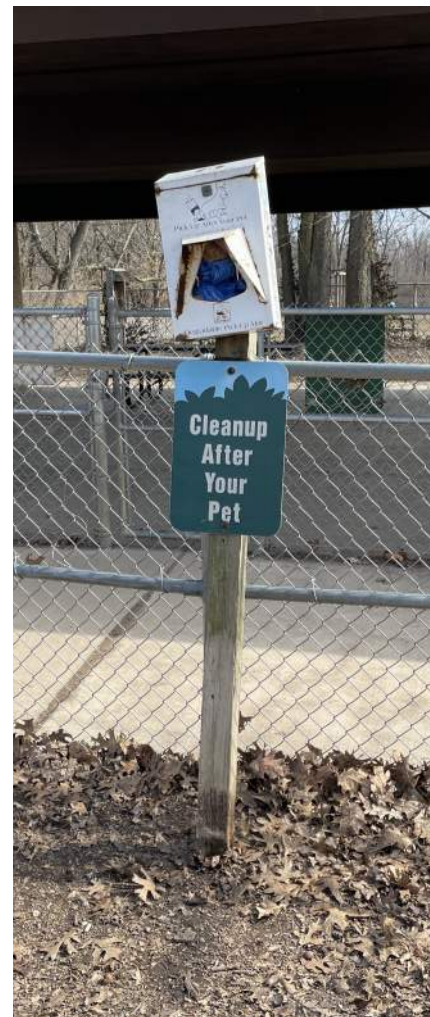
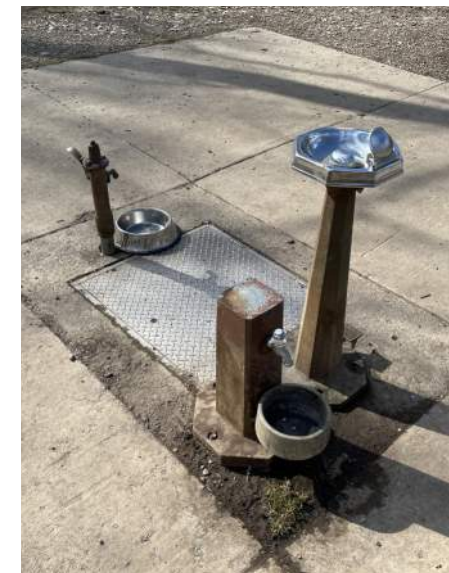
## OUTDATED AMENITIES

- Amenities throughout the park are in various states of aging and decay, past their useful lifespans, and in need to repair, replacement, or removal.
- Additional tables have been added, however they are haphazardly placed around the park rather than more organized.
- Amenities to be addressed include:
  - Picnic Tables
  - Benches
  - Trellis Shade Structures
  - Trash Cans
  - Dog Waste Bag Stations
  - Park Signs
  - Grill Stations
  - Water Fountains and Bowls

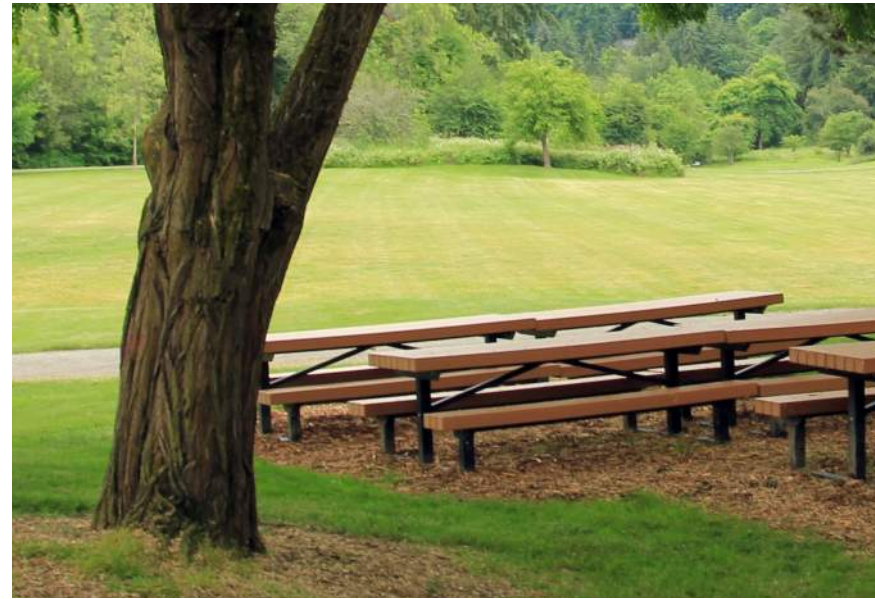
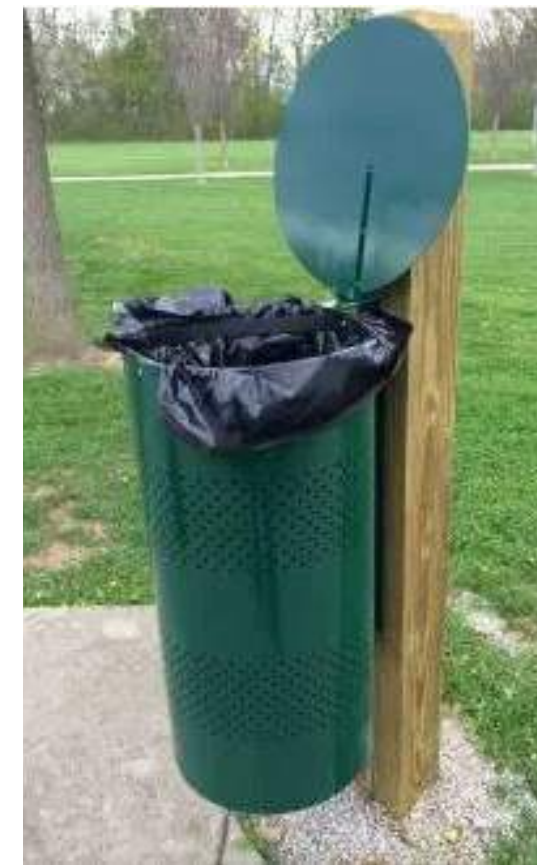
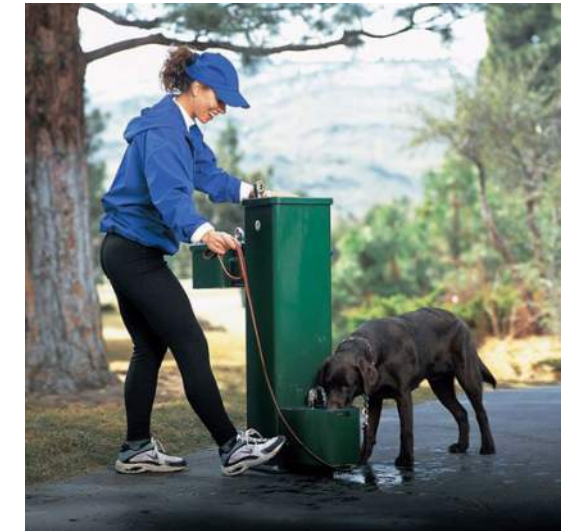
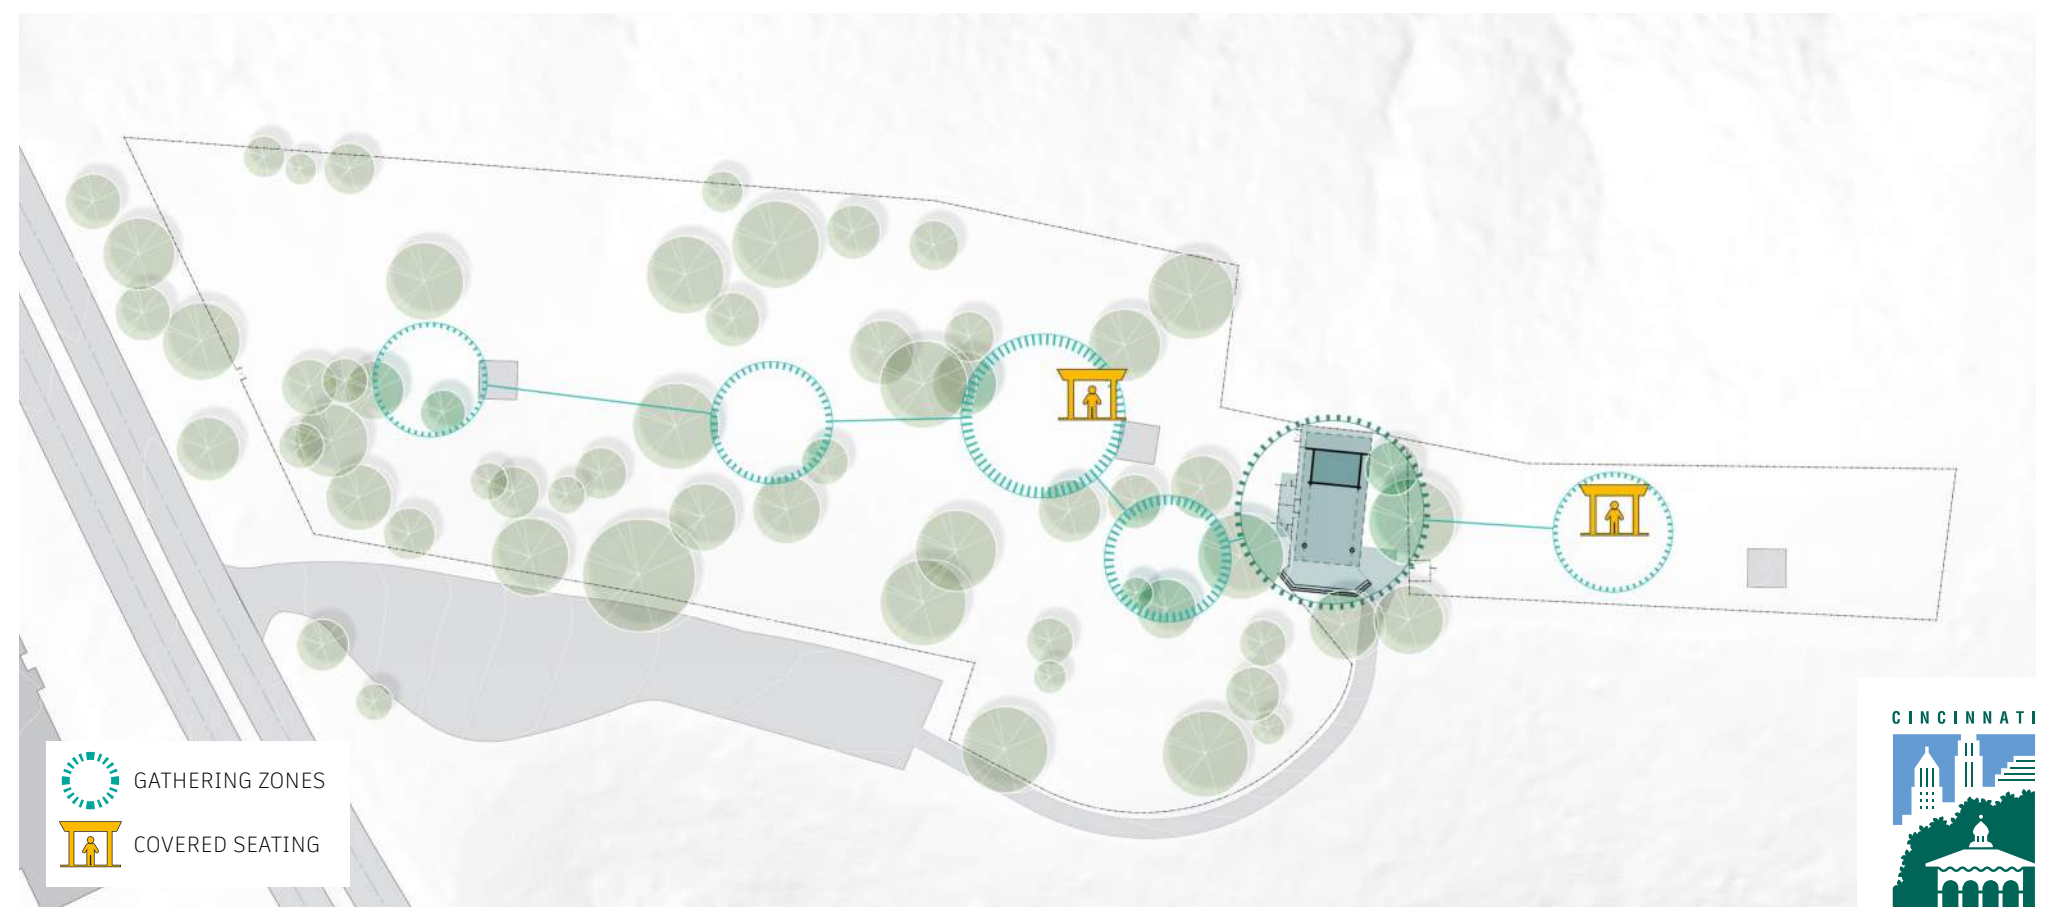
## ORGANIZE / ADD AMENITIES

- Introduce additional seating as needed and organize in grouped gathering zones along dog run perimeter.
- Upgrade and install additional waste receptacles and disposal bag stations at dog area perimeters.
- Update water fountain amenities to include built-in dog bowl and pool filler.
- Opportunities for constructing additional shade structures may be explored with public partnerships.

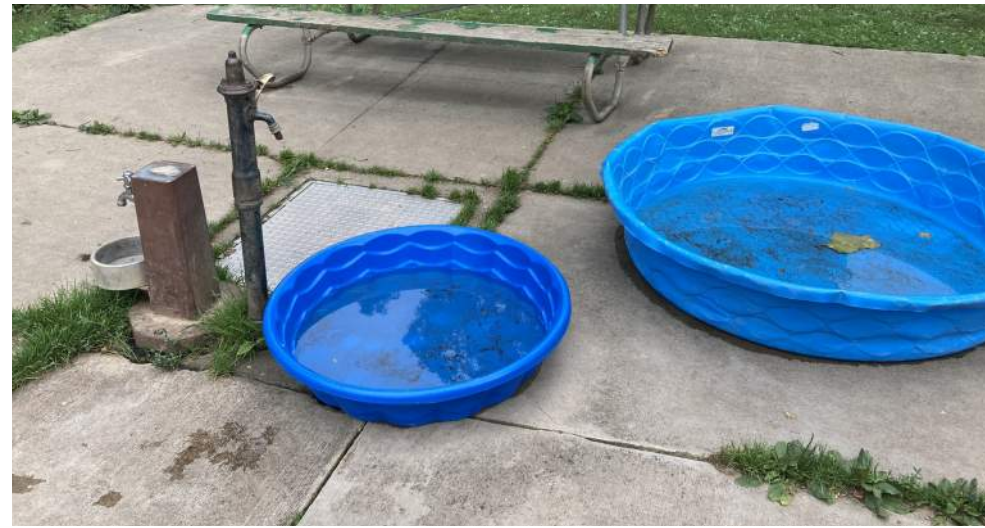
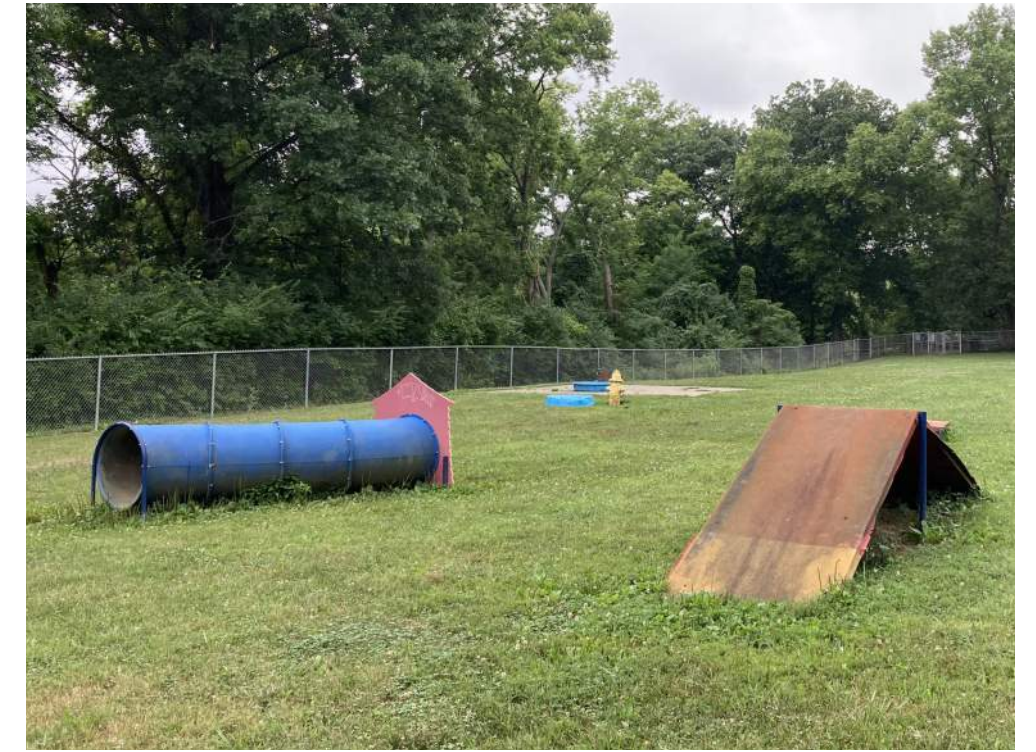
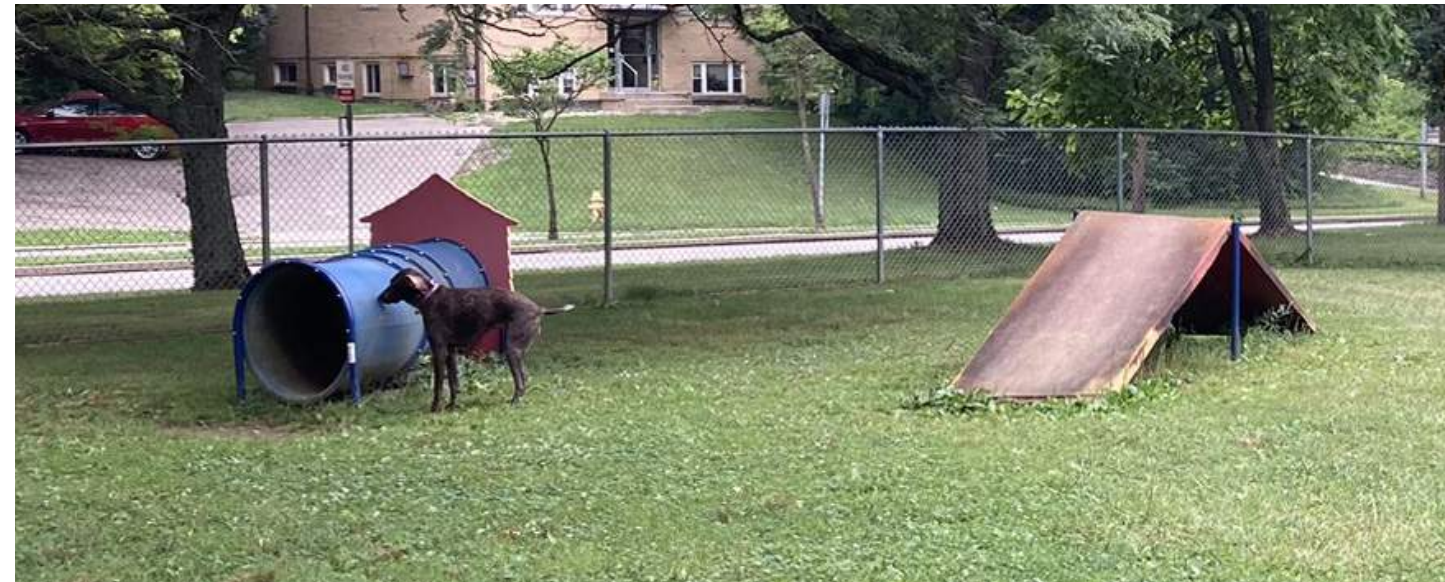
## AGE OF PLAY EQUIPMENT

- Play equipment in the park is in various states of age and deterioration, and is way past it's useful lifespans.
- Current play equipment offerings are minimal and underutilized, a broadening of equipment types would likely result in more engagement and dog play.
- No natural material integration in existing equipment.

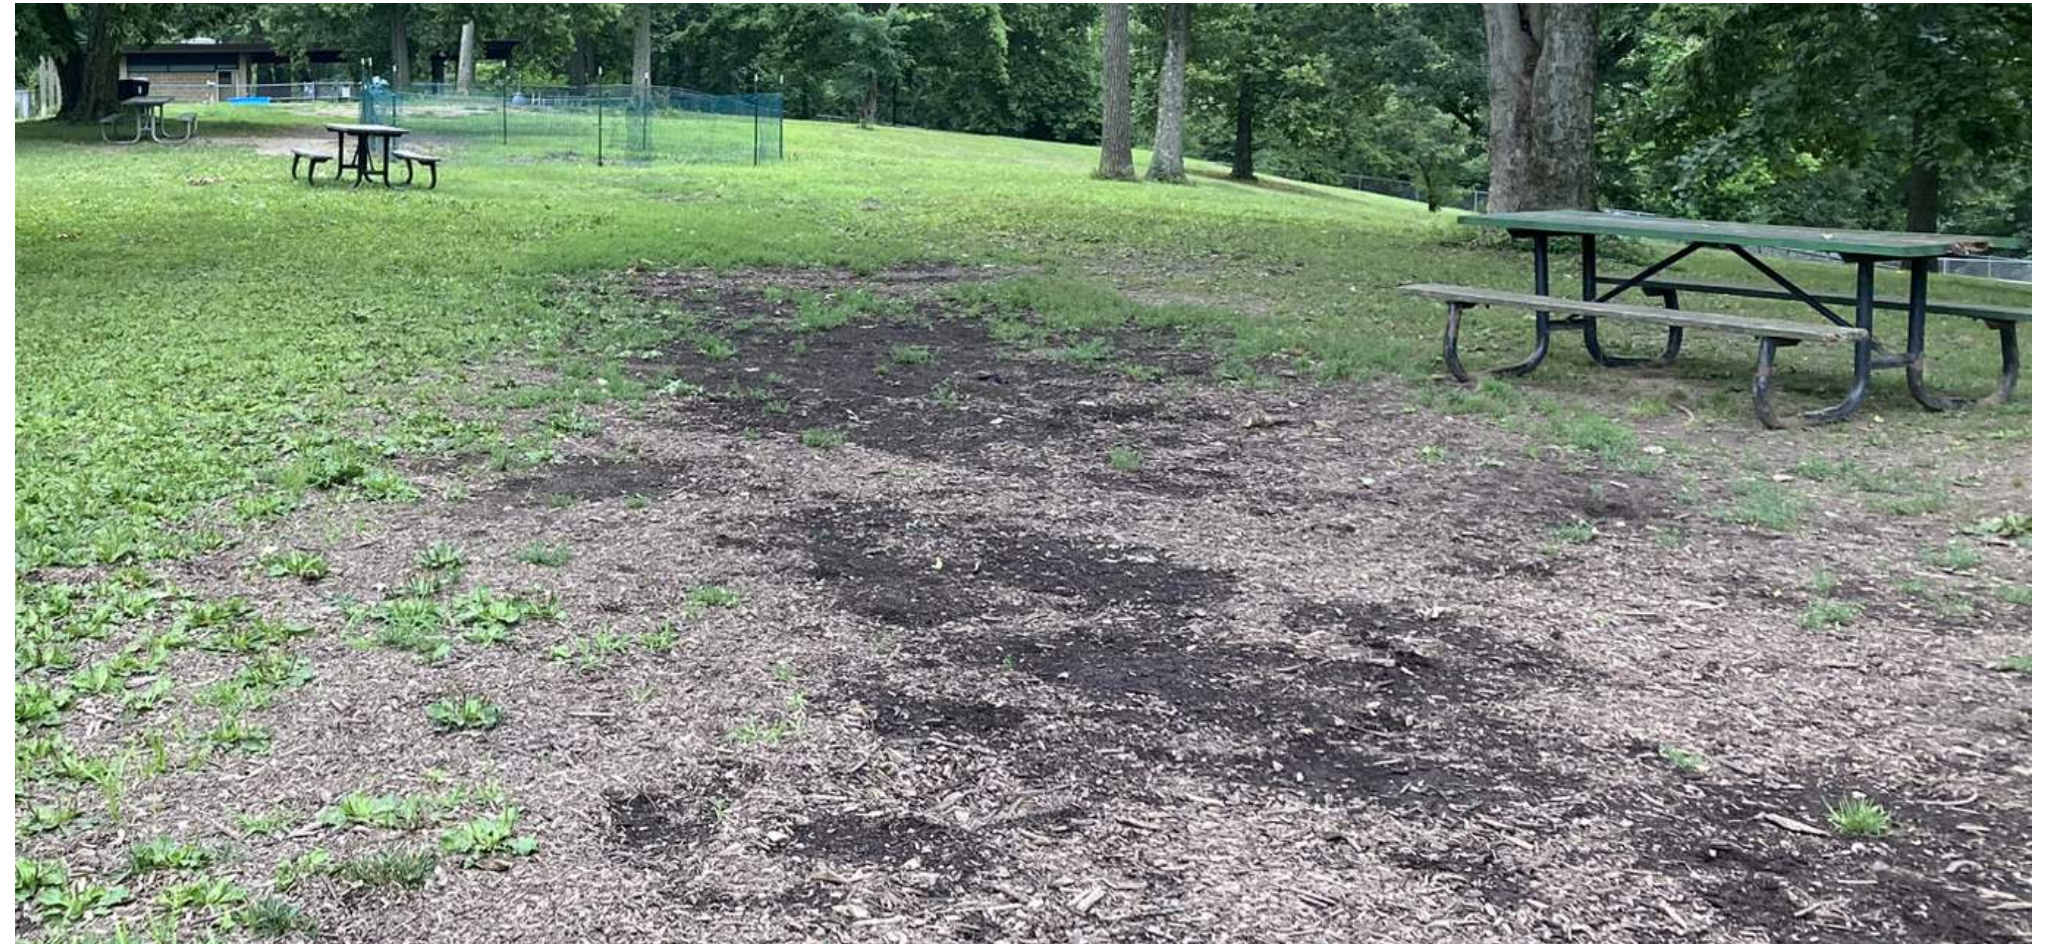
- Heavy-use and runoff removes mulch and topsoil over time.
- Exposed dirt and soil is prone to erosion and runoff, further exacerbating the problem.
- Loss of soil exposes roots systems, which are a potential tripping hazard.

EROSION-PRONE PROBLEM AREAS
