# DORIS DAY DOG PARK RENOVATIONS & IMPROVEMENTS

2970 WESTWOOD NORTHERN BLVD, CINCINNATI, OH 45211

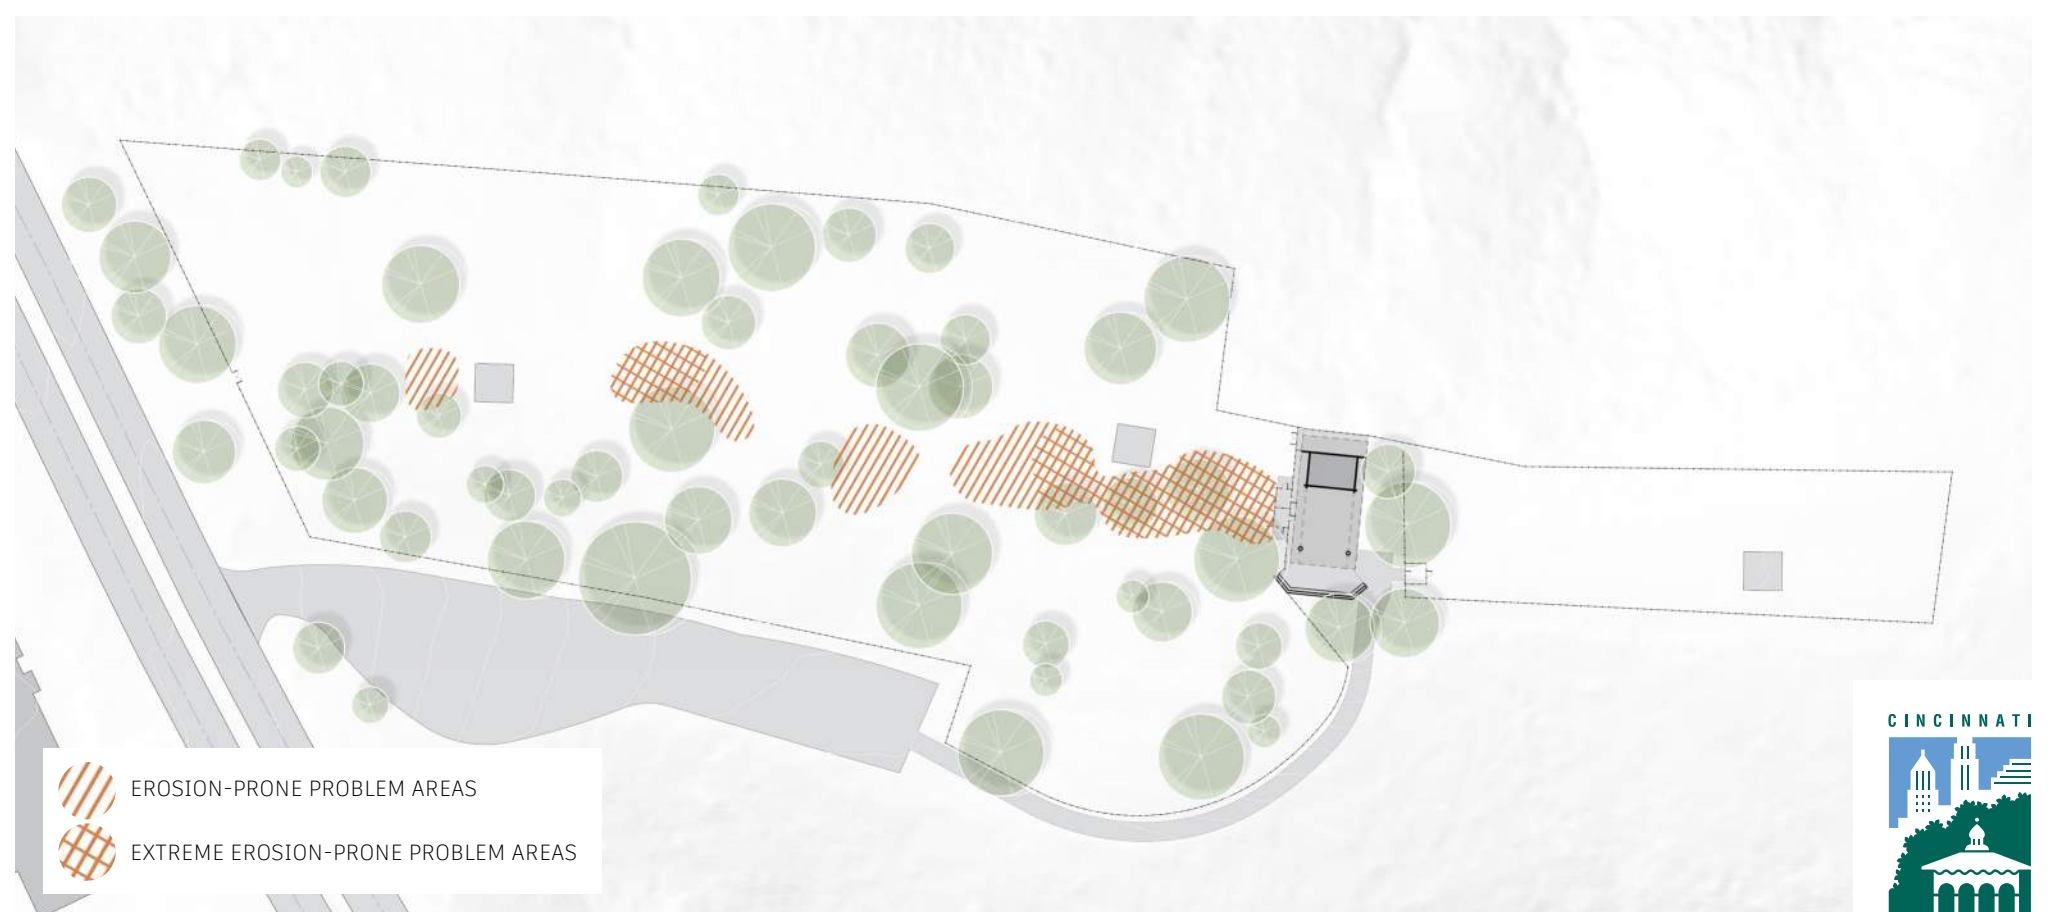
- Heavy-use and runoff removes mulch and topsoil over time.
- Exposed dirt and soil is prone to erosion and runoff, further exacerbating the problem.
- Loss of soil exposes roots systems, which are a potential tripping hazard.

EXTREME EROSION-PRONE PROBLEM AREAS

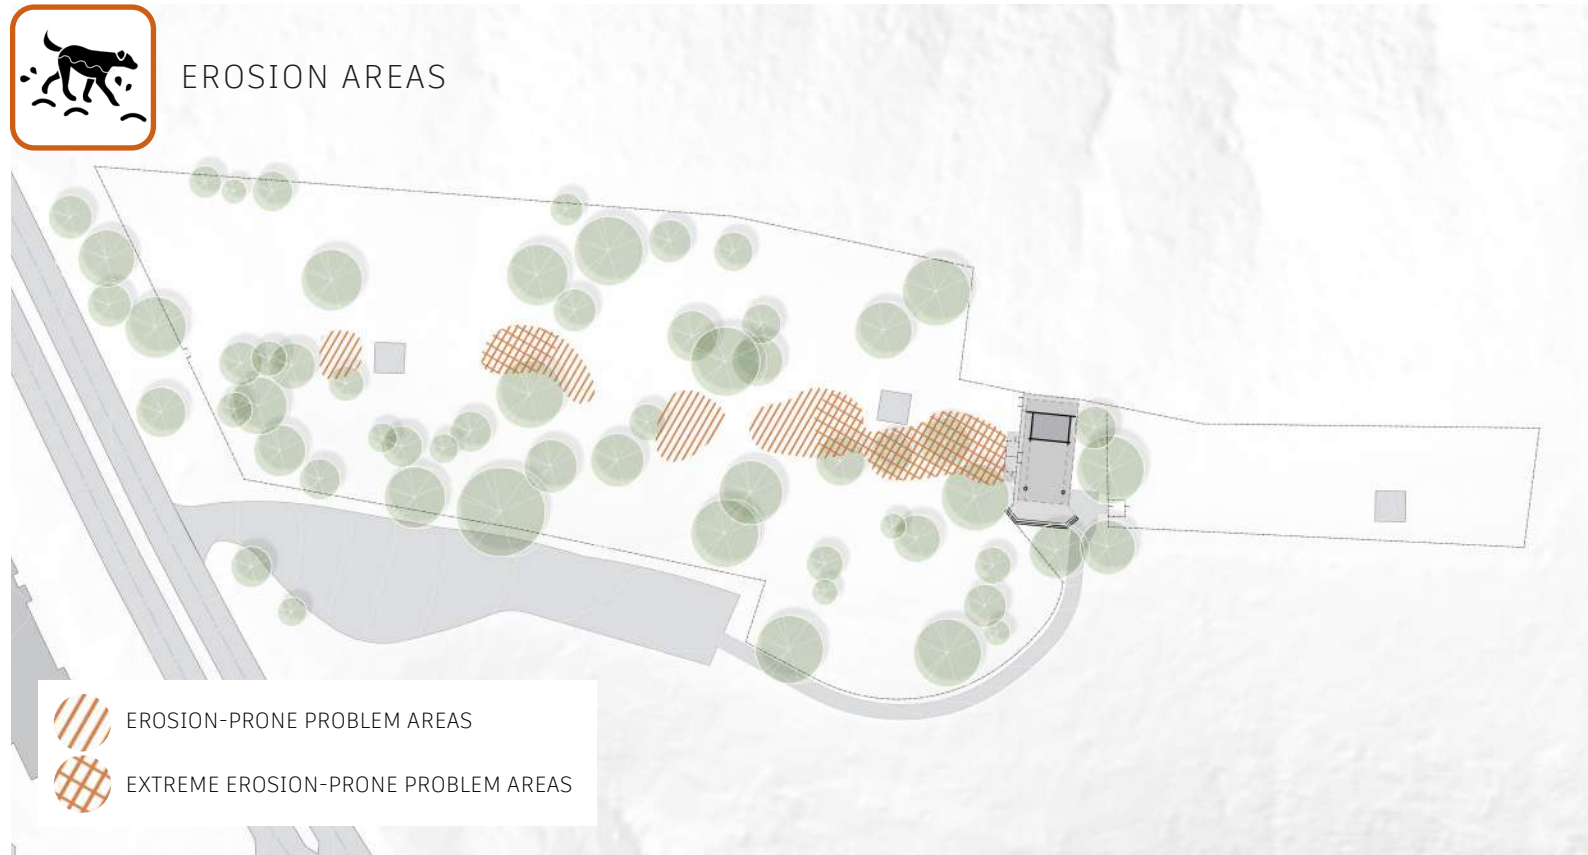
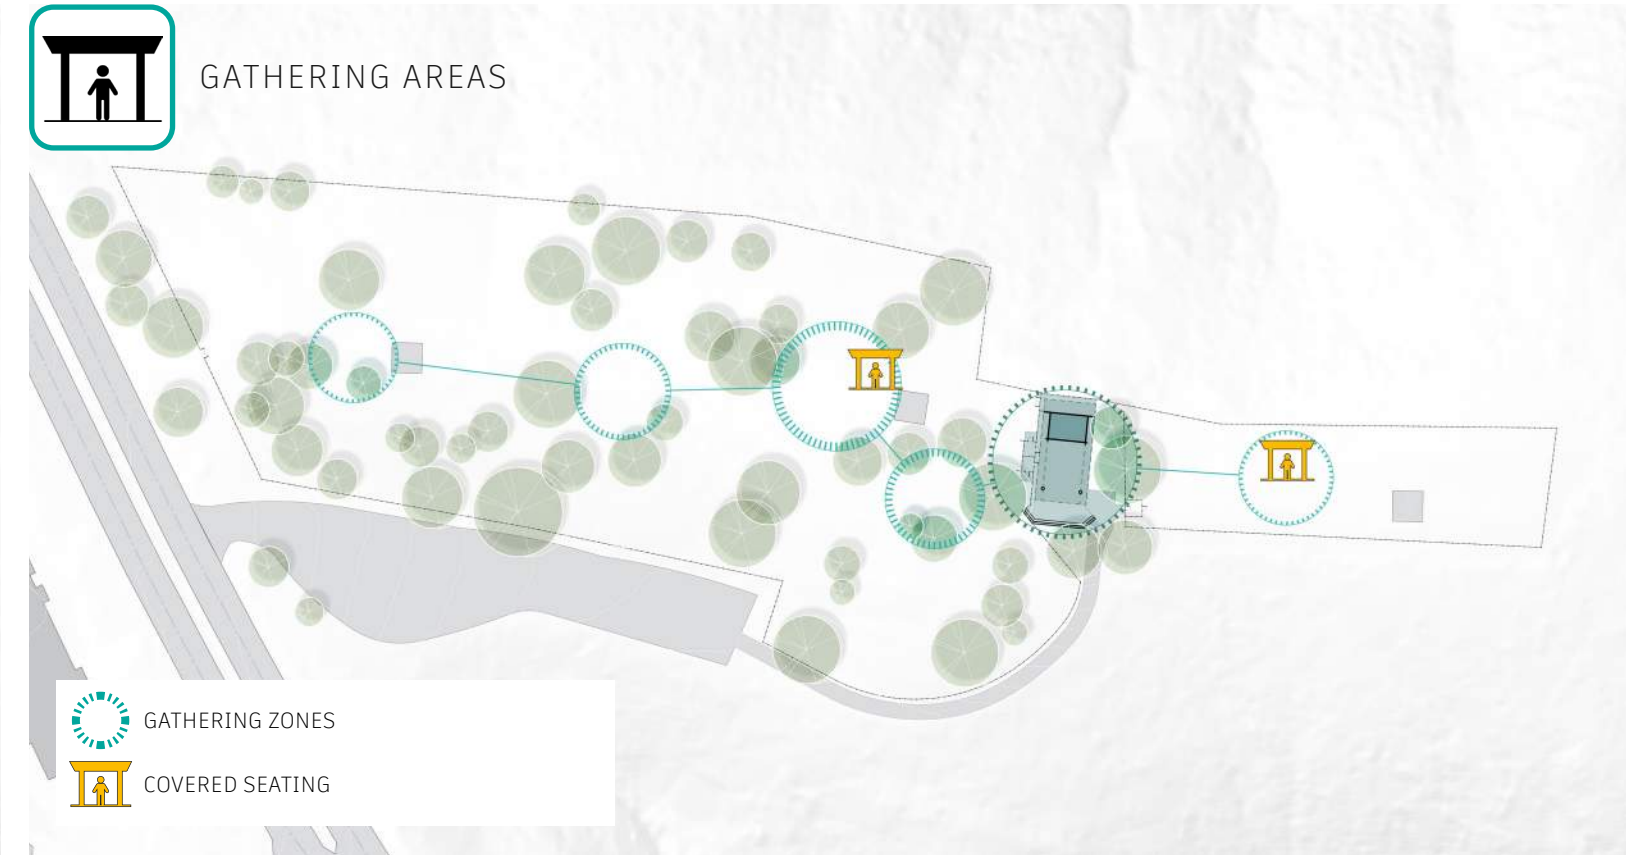
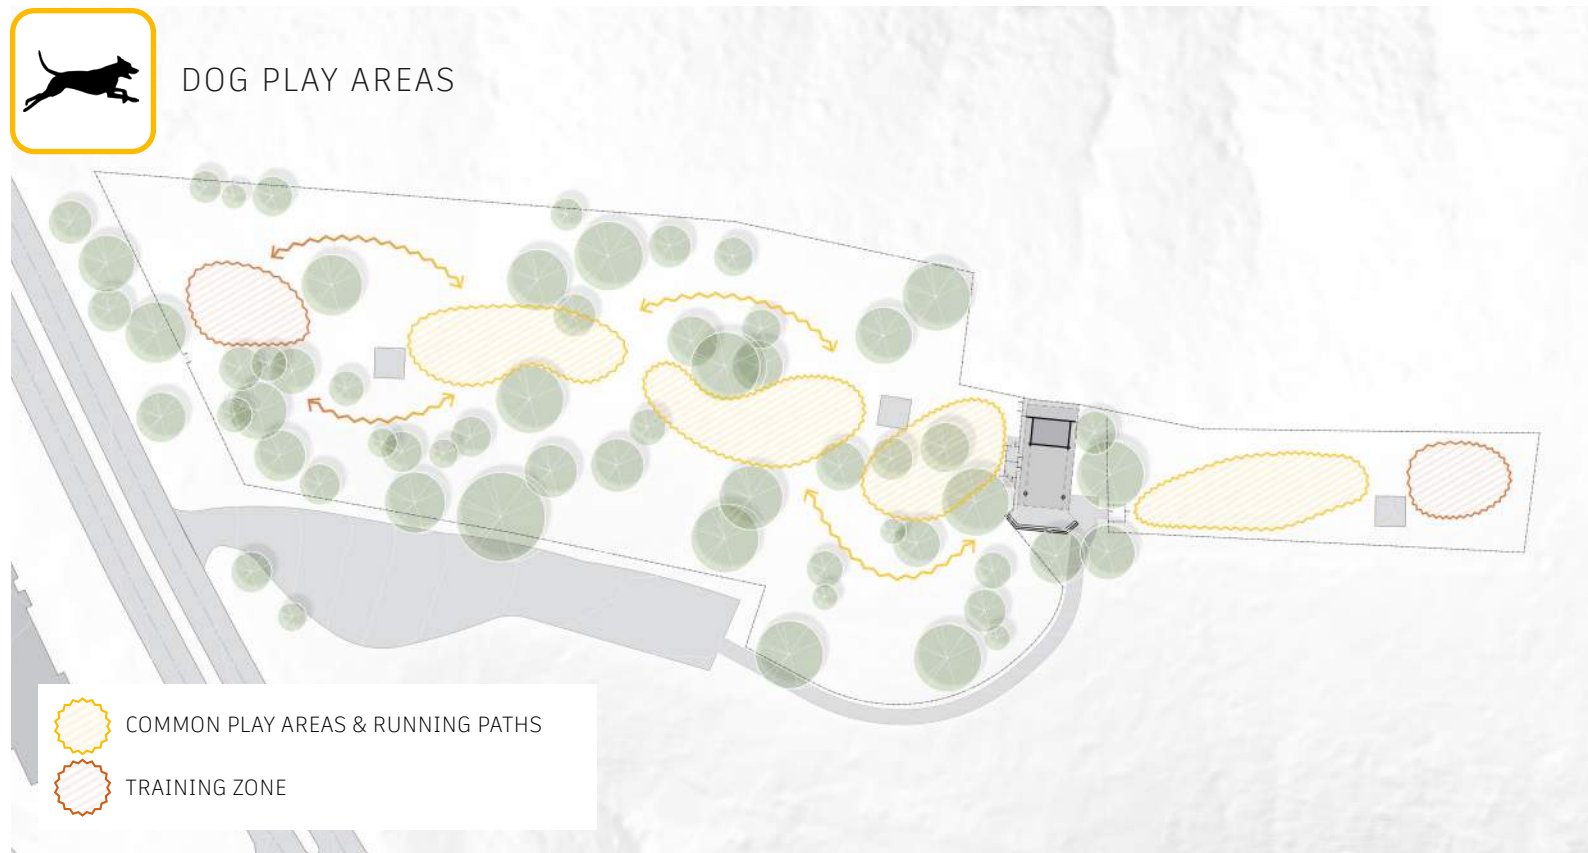
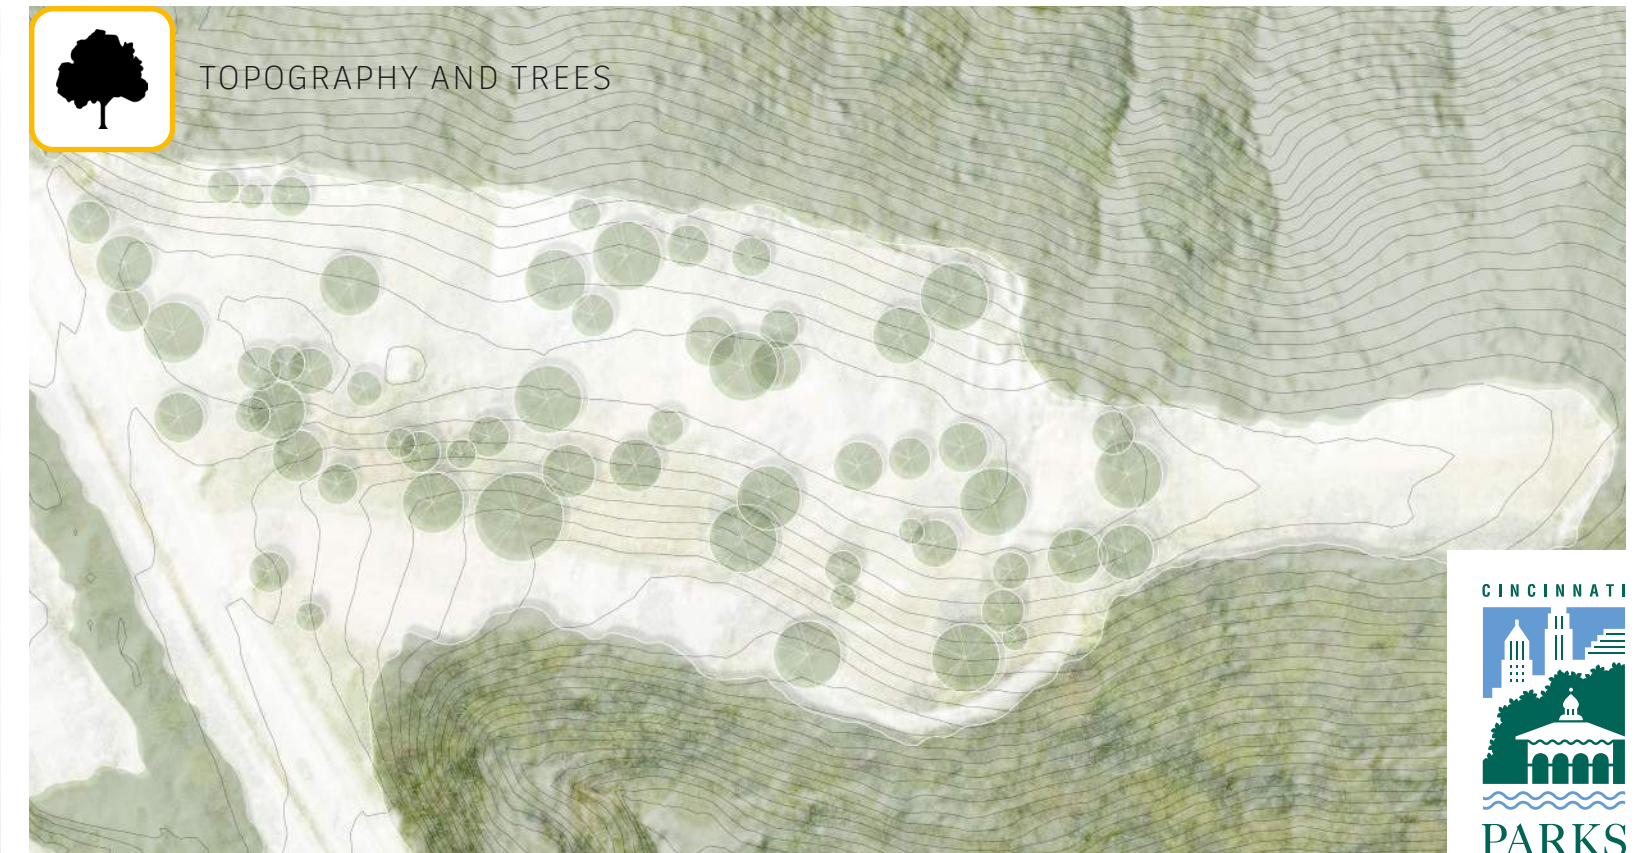
# DESIGN DRIVERS

Identifying diagrammatic factors of the site.

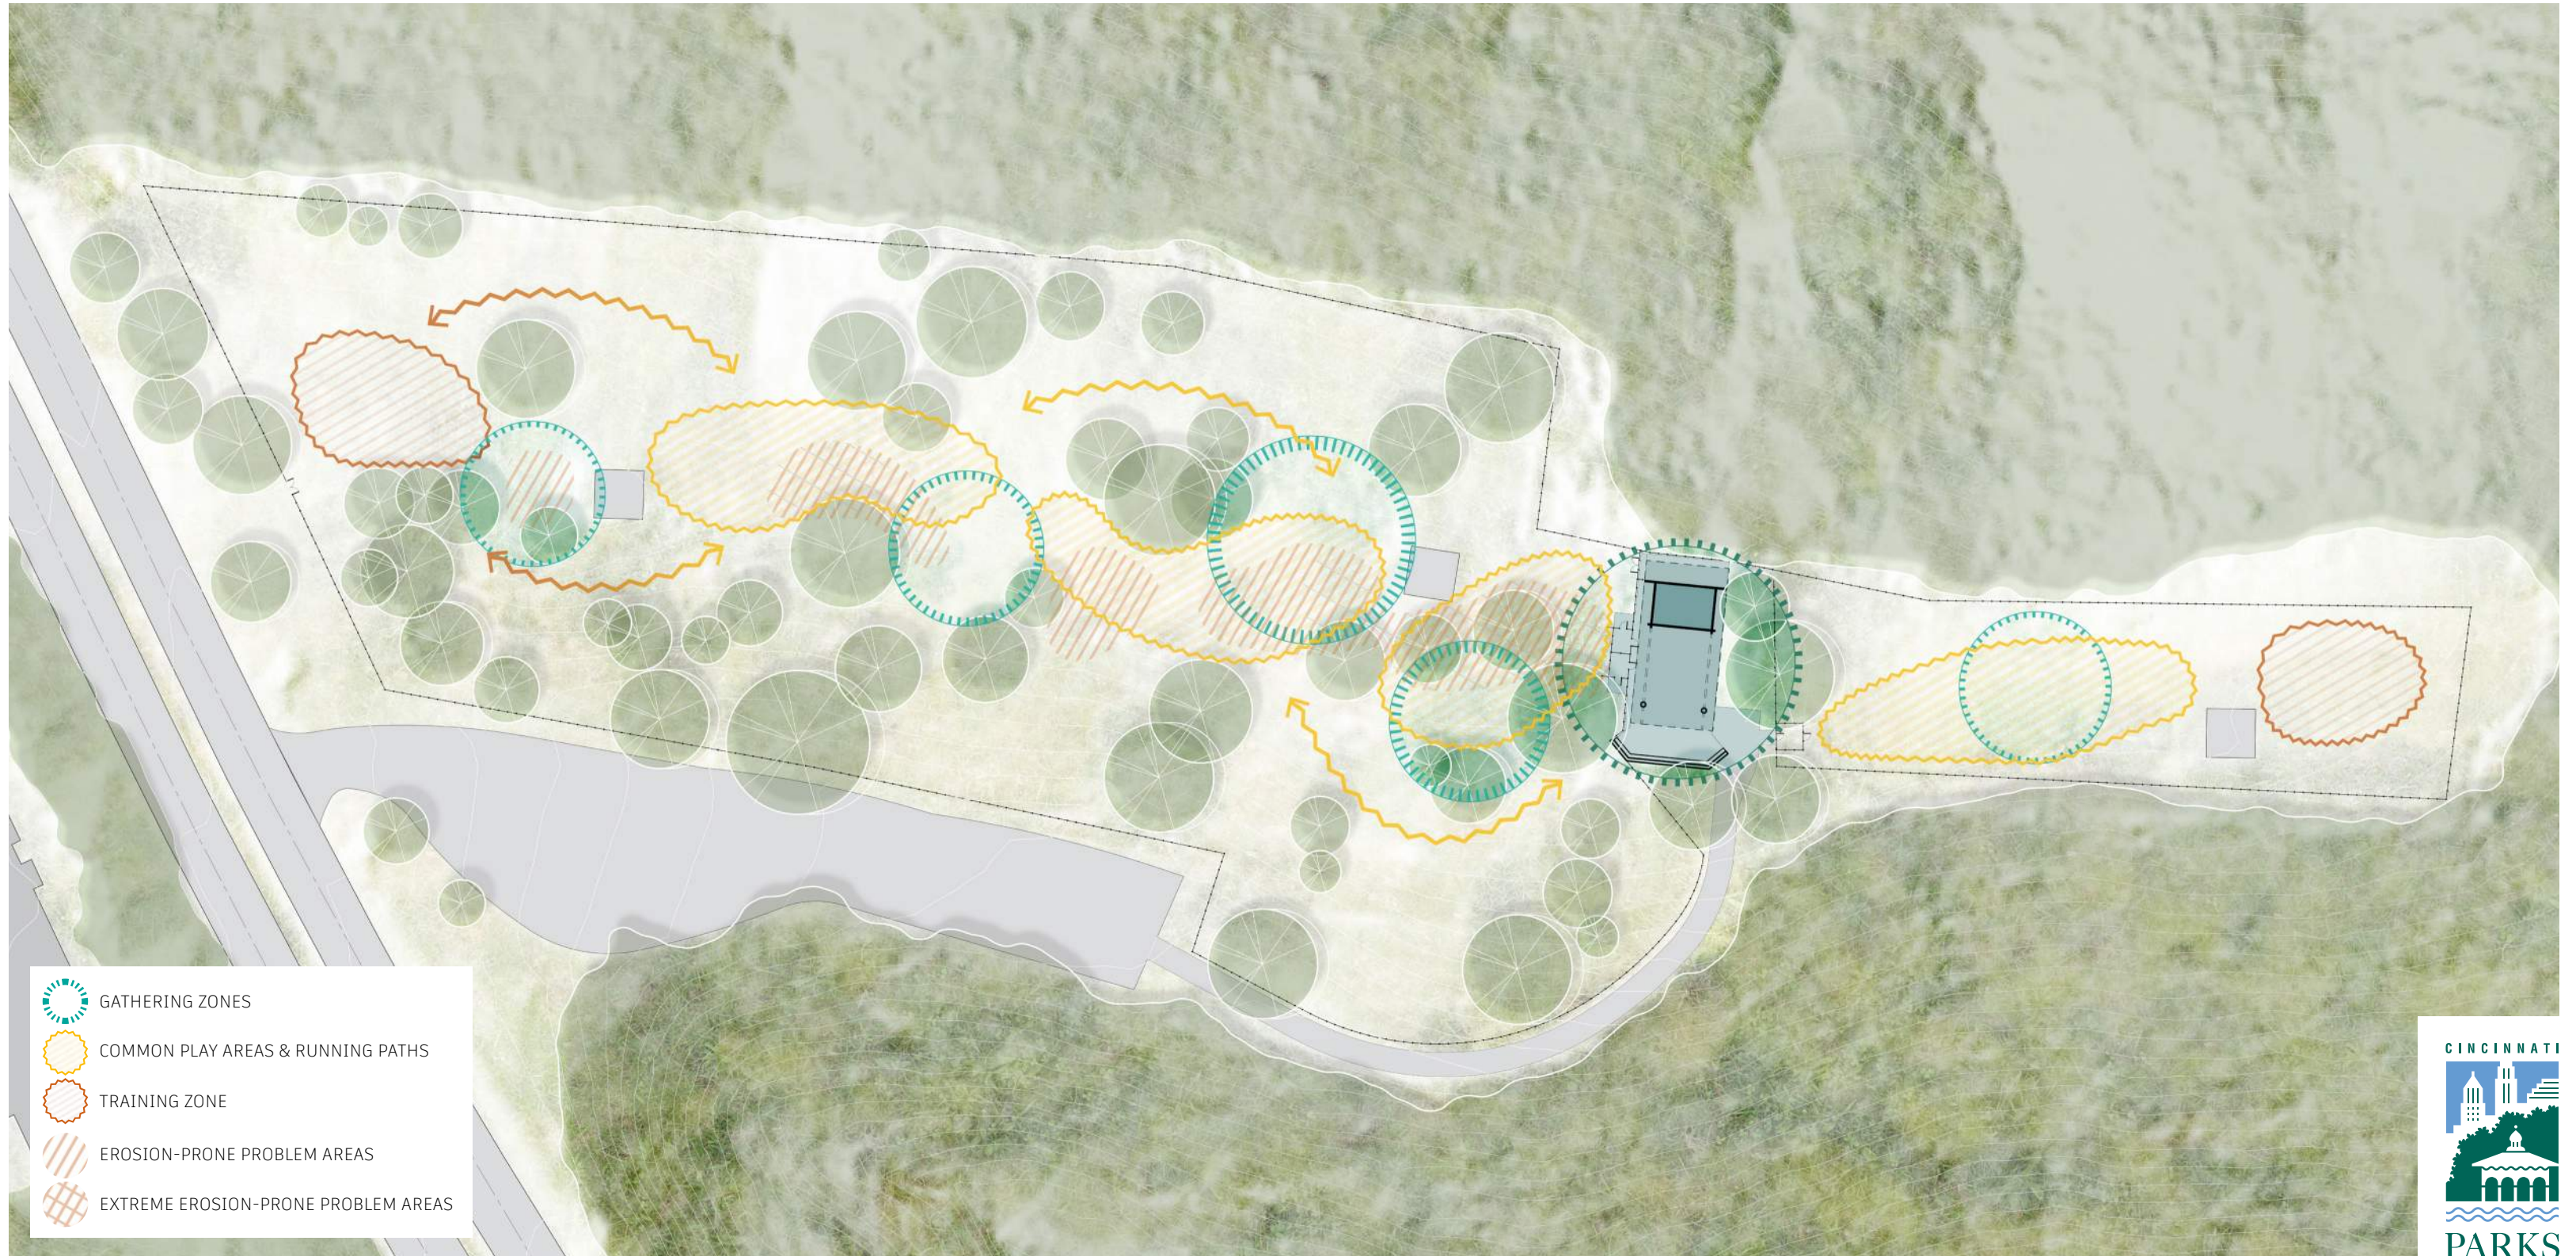
# DESIGN DRIVERS

Overlaying these site factors can often lead to designs starting to reveal themselves. Places which are erosion-prone and where dogs actively play overlap, and are the best candidates for resurfacing. The middle, or “ridge”, of the park should be treated as the primary core of the dog play zone. Places where people naturally congregate should have concentrated amenities and be on the dog run perimeter.

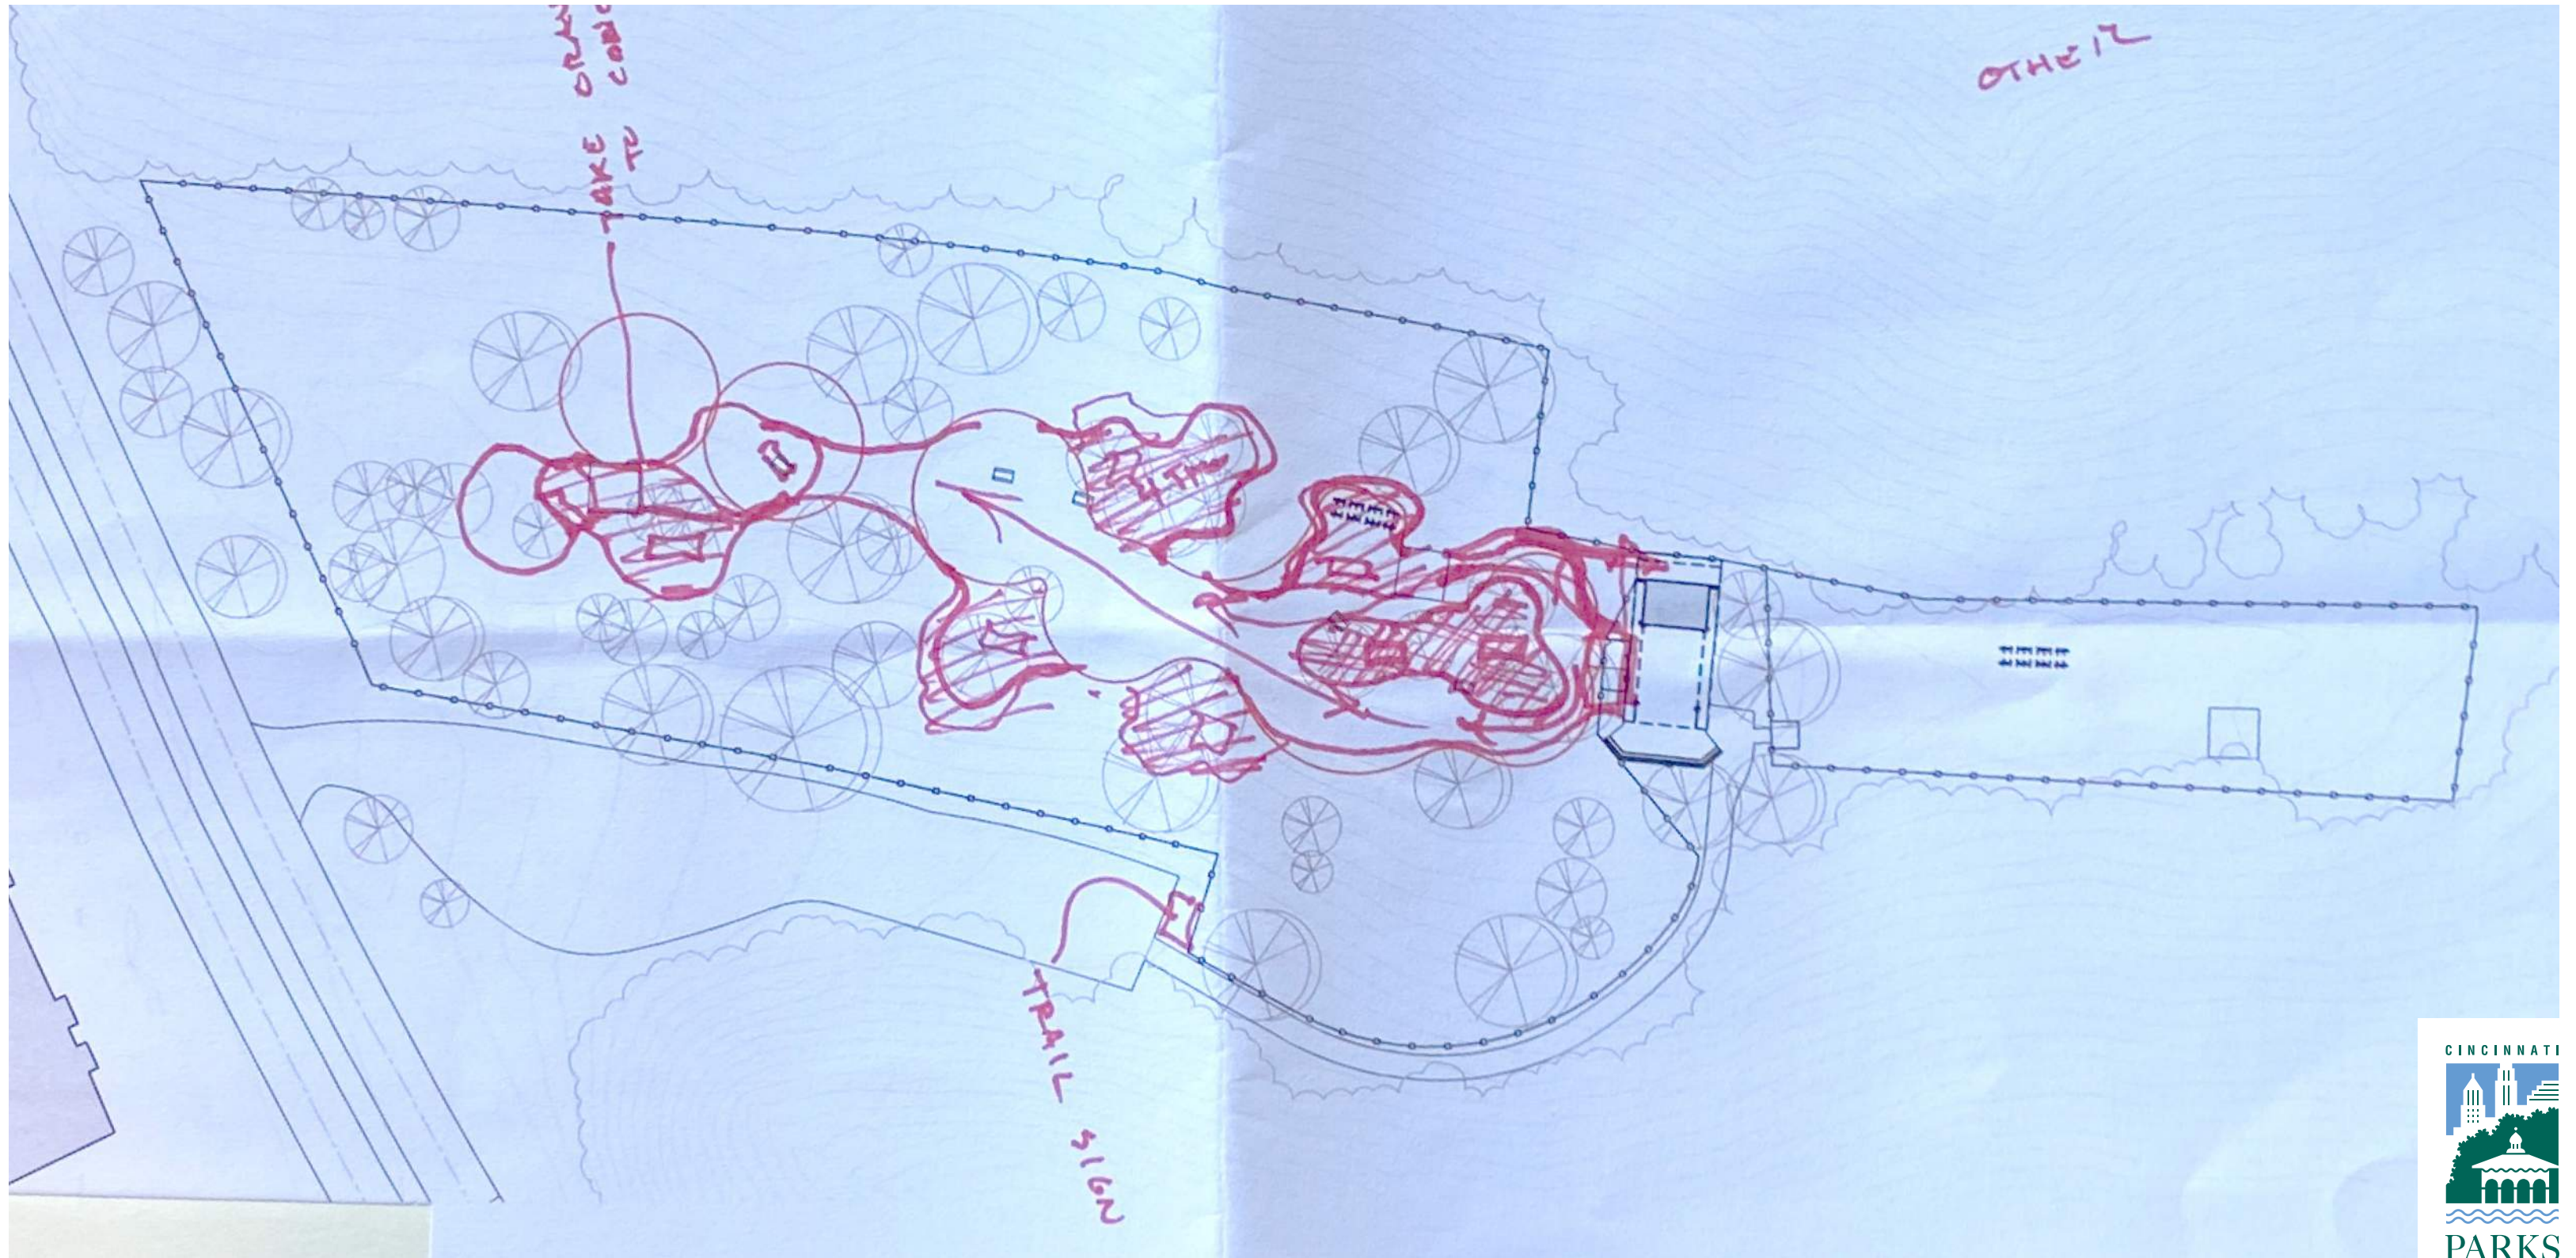
# EARLY DESIGN SKETCHES

After an analysis of site and use factors, initial sketches were made that centered around the idea of providing the dog run at the spine of the park, while organizing seating pods at its perimeter to foster community togetherness.

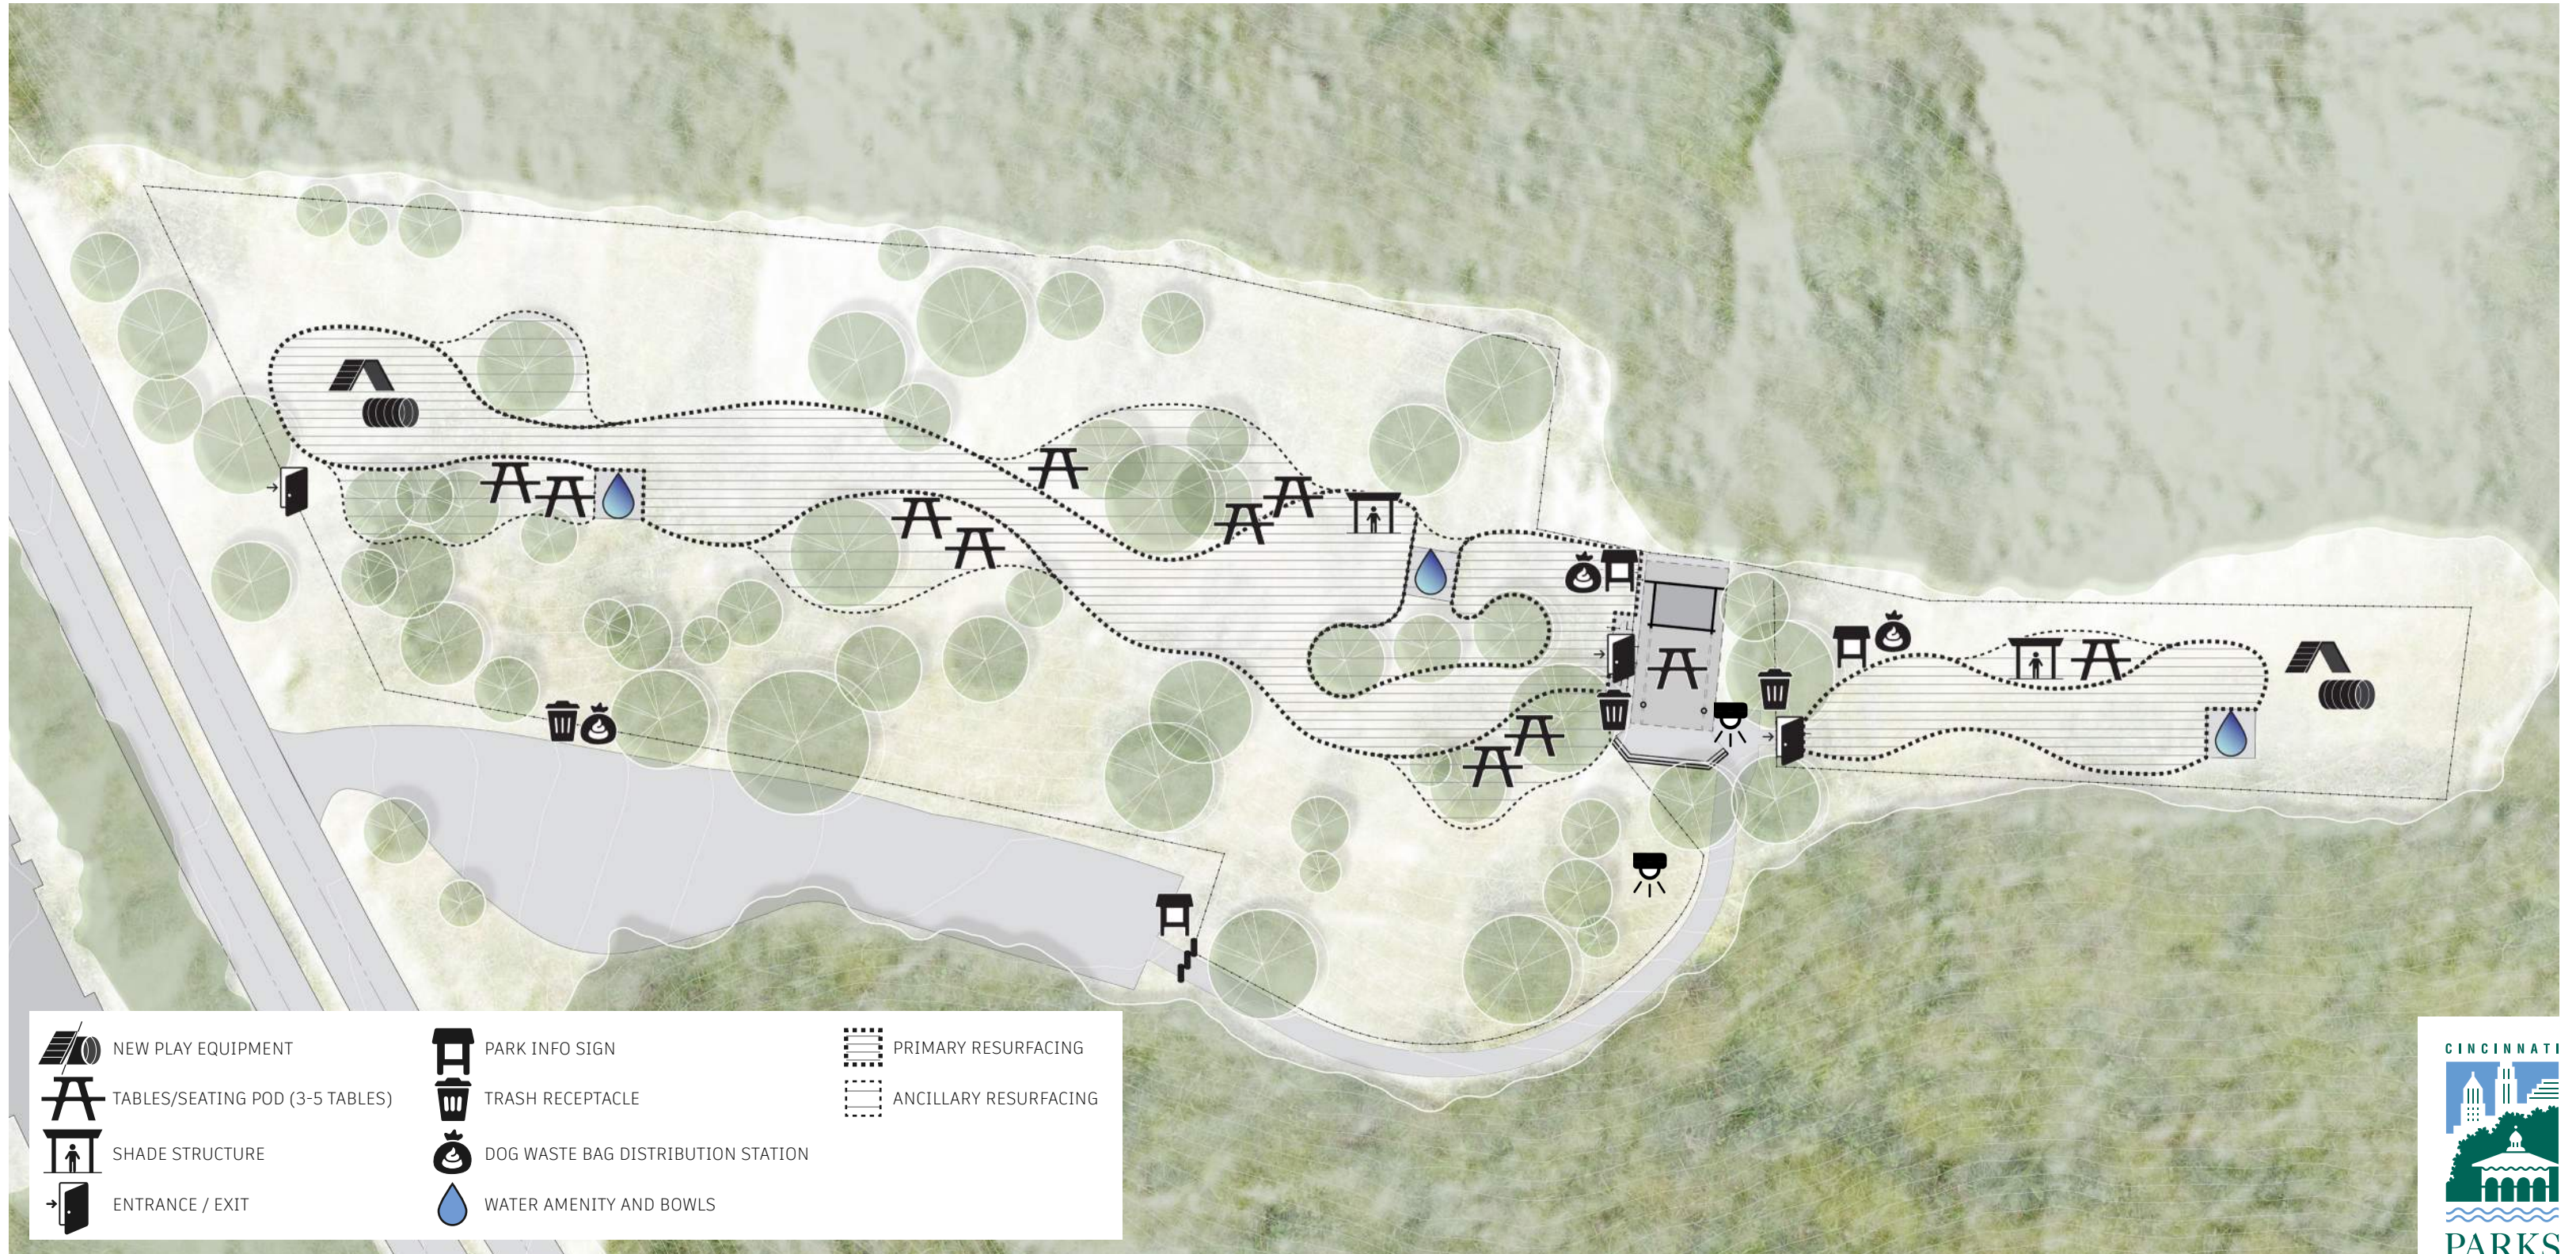
# DESIGN CONCEPT - LONG DOG RUNS W/ ANCILLARY GATHERING NODES

- Capitalizes on long runs for energetic dogs
- Reduced impact of erosion, improving maintainability.
- Maintains important features, such as water amenities and shaded structures.
- Organizes gathering areas to foster community togetherness.
- Trash amenities on park perimeter for access and ease of maintenance.
